**PERVIOUS CONCRETE EVALUATION
MATERIALS INVESTIGATION
DENVER, COLORADO**

**URBAN DRAINAGE AND FLOOD CONTROL DISTRICT
2480 West 26th Avenue
Suite #156-B
Denver, Colorado**

Project No. CT14,571-356

November 6, 2008

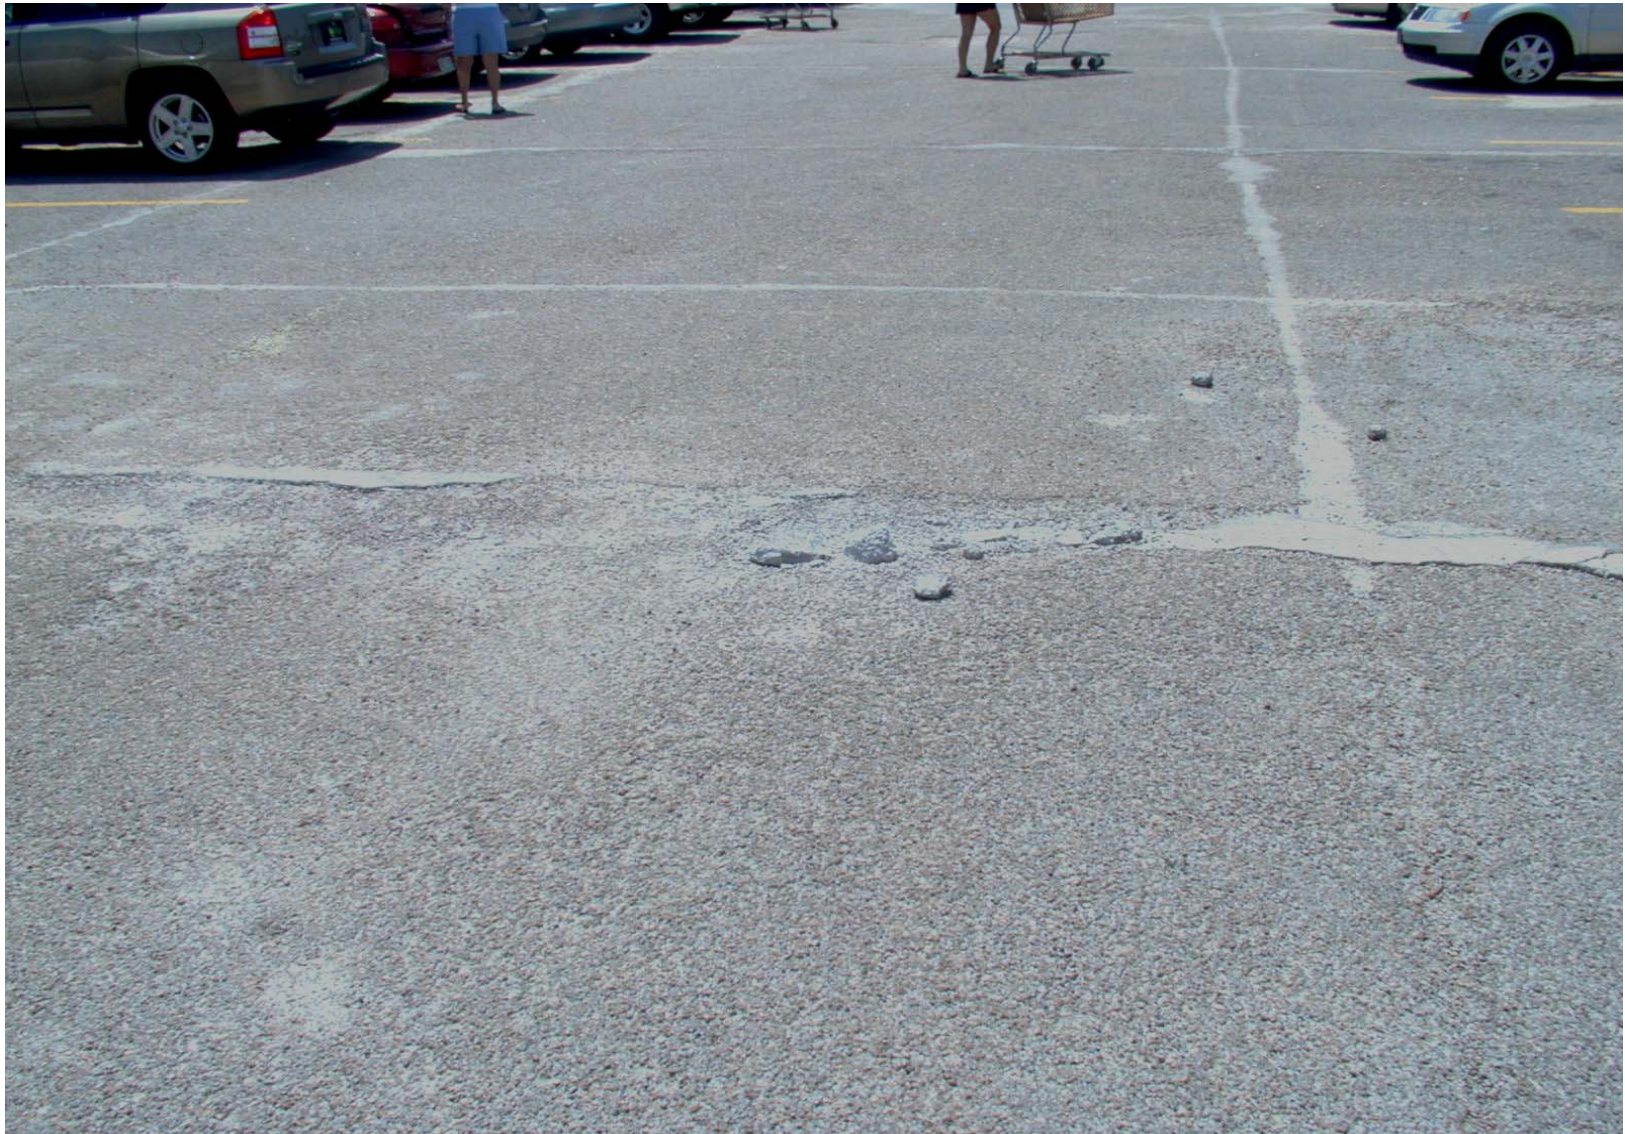
The pervious concrete at Site B was experiencing significant deterioration and servicability was impacted. Select repairs had been performed due to deterioration of the surface.

Photo 1 Site B - distressed areas patched with non-pervious concrete.

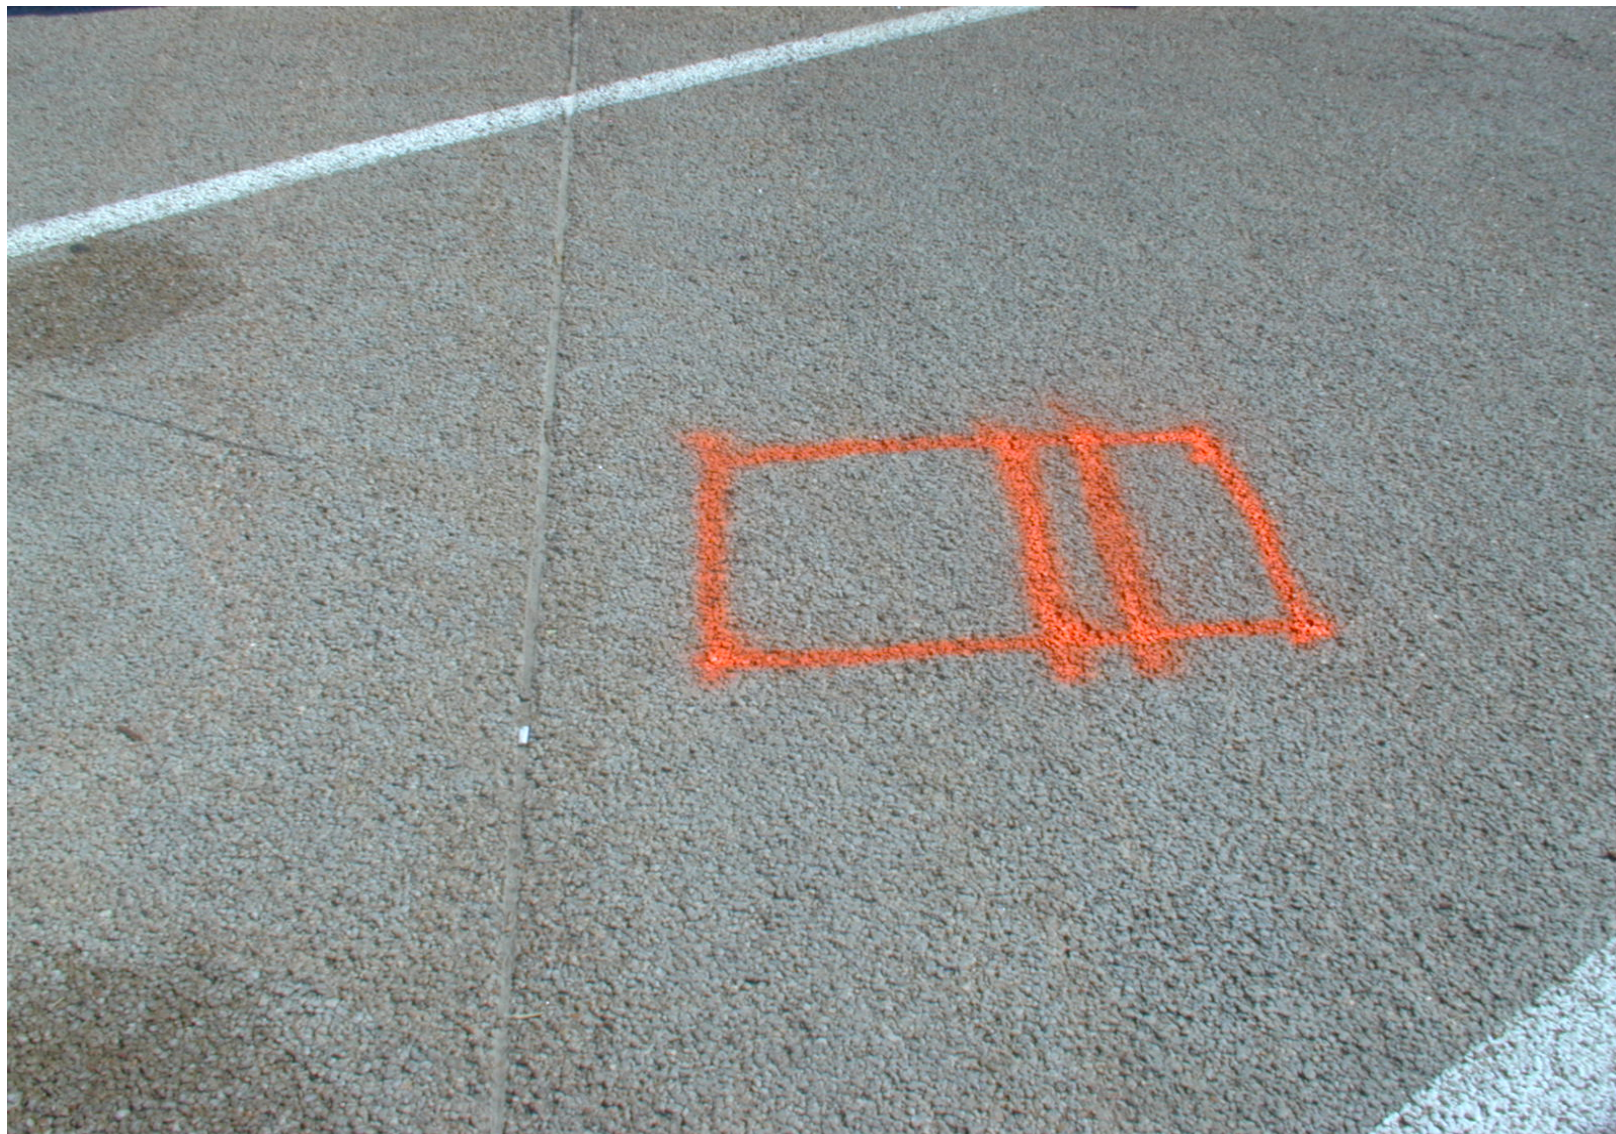
Photo 2 Site B - distressed pervious concrete.

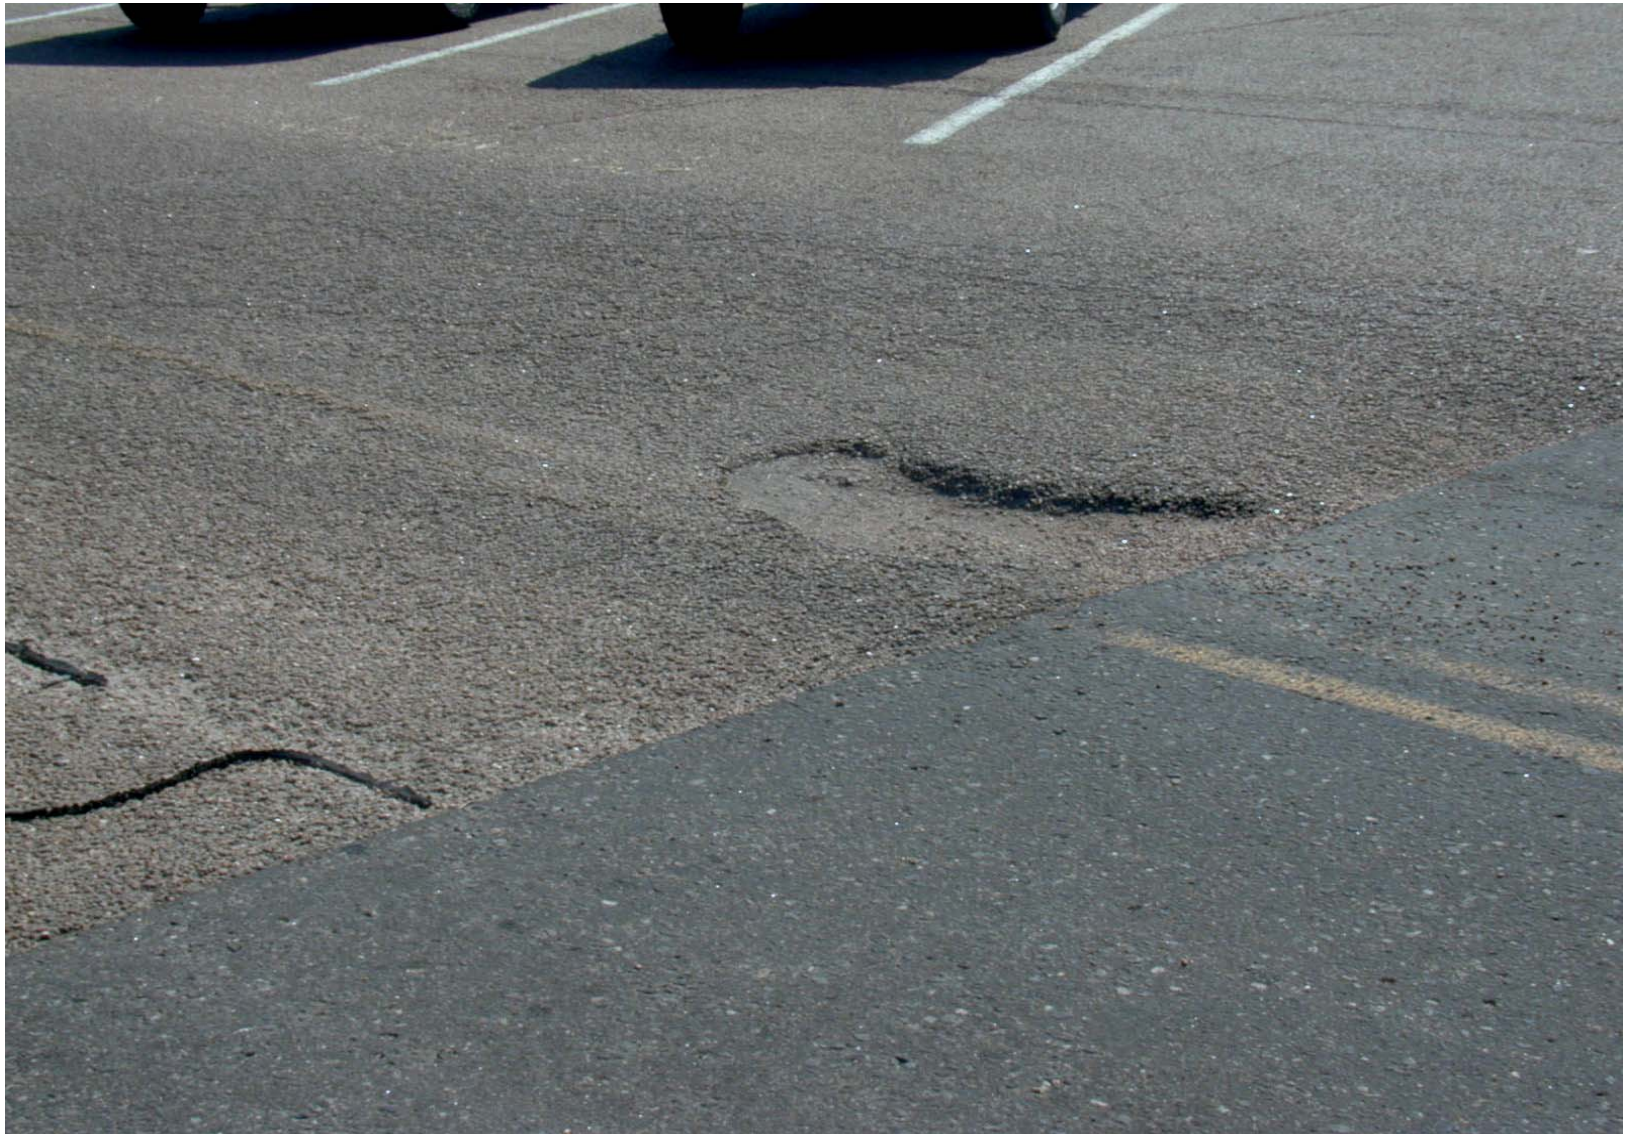
The pervious concrete at Site C was experiencing minimal deterioration and servicability was not impacted.

Photo 3 Site C - non distressed portion of pervious concrete.

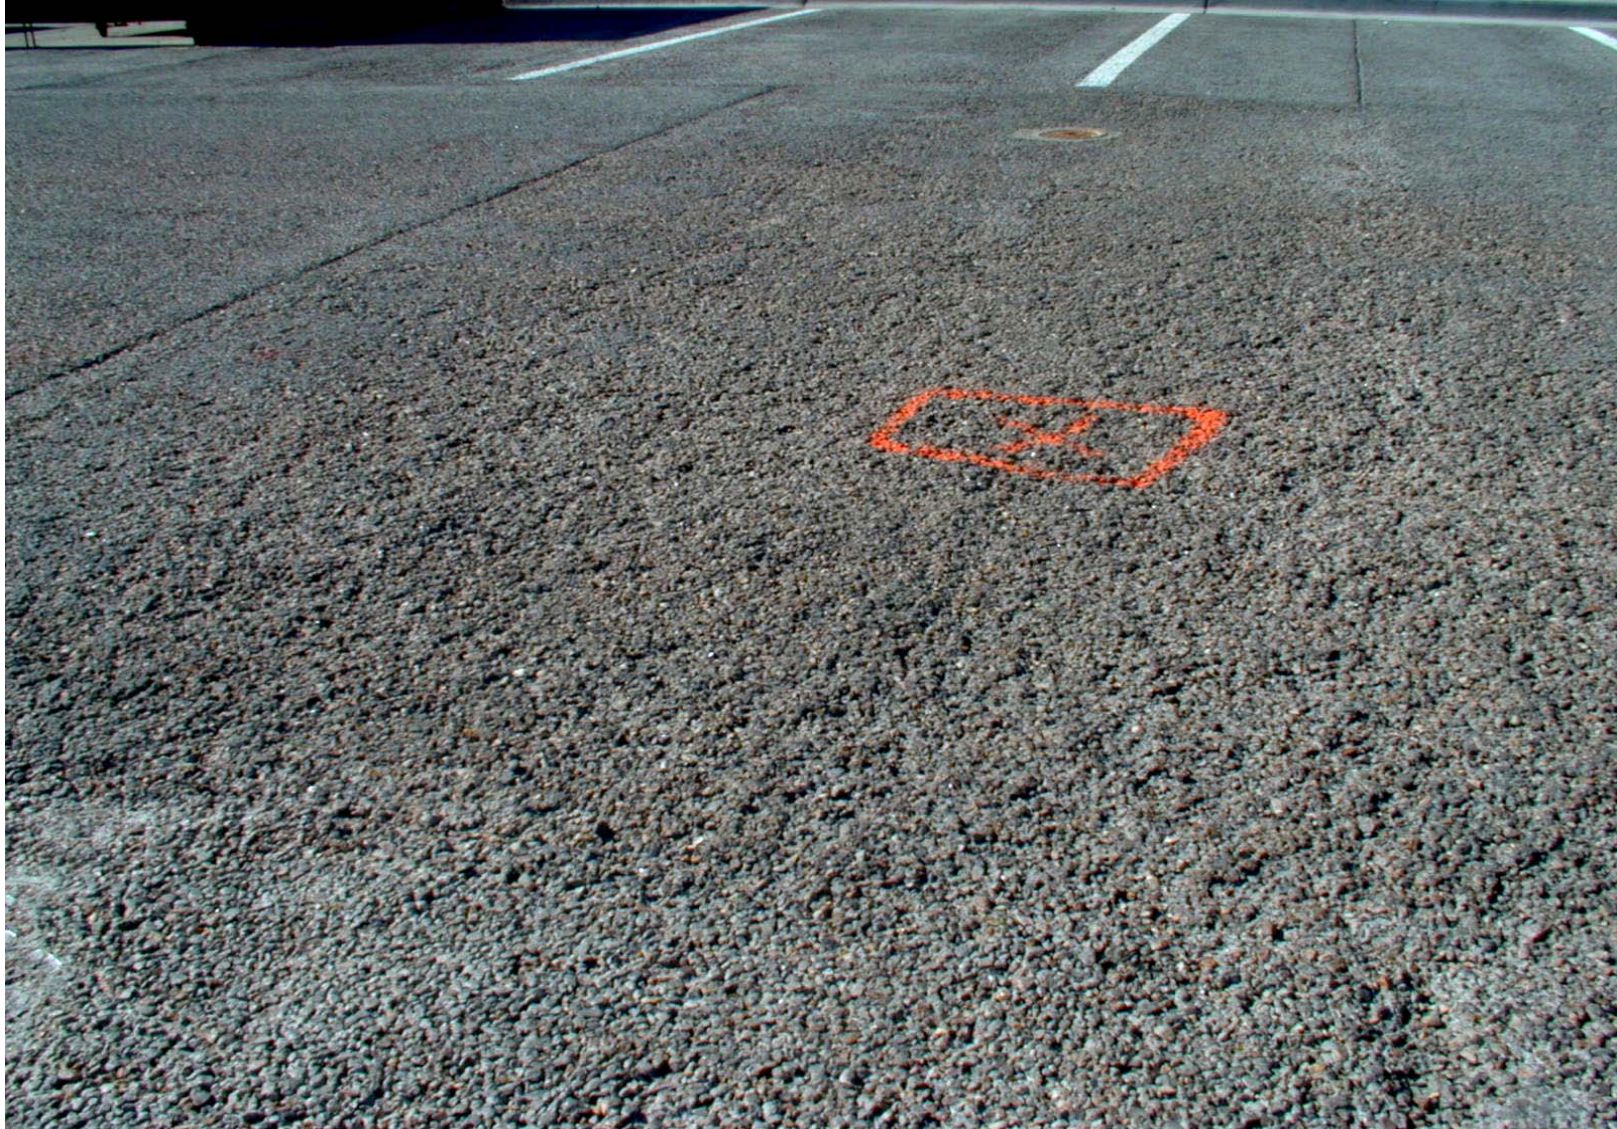
from 5.0 inches to 8.1 inches (Table I). Measurements of deterioration depth of the wearing surface ranged from no erosion (Site A, control site) to ½” to 2” for the distressed sites. Two of the distressed sites exhibited significant surface erosion (e.g., potholes, Photo 4) and select patching/repairs were in progress (Photos 1 & 2).

Photo 4 Site C - distressed pervious concrete.

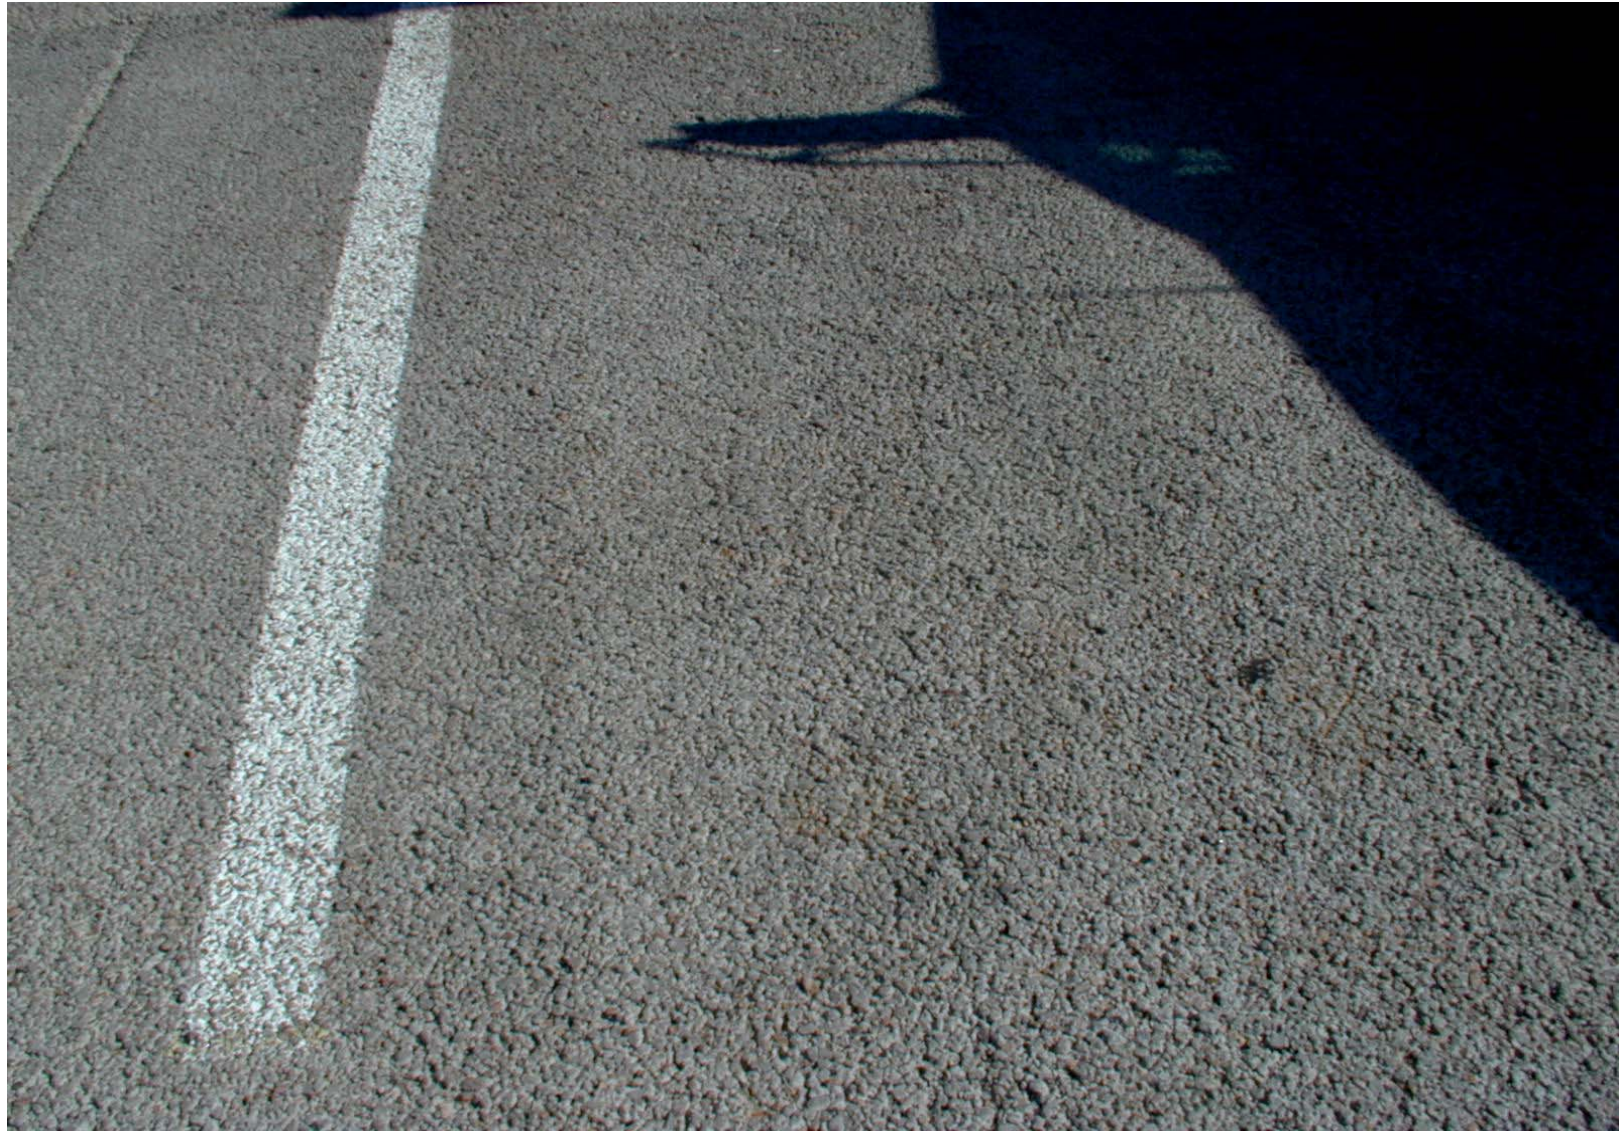
The pervious concrete at Site D was experiencing significant deterioration and servicability was impacted.

Photo 5 Site D - surface distress to pervious concrete.

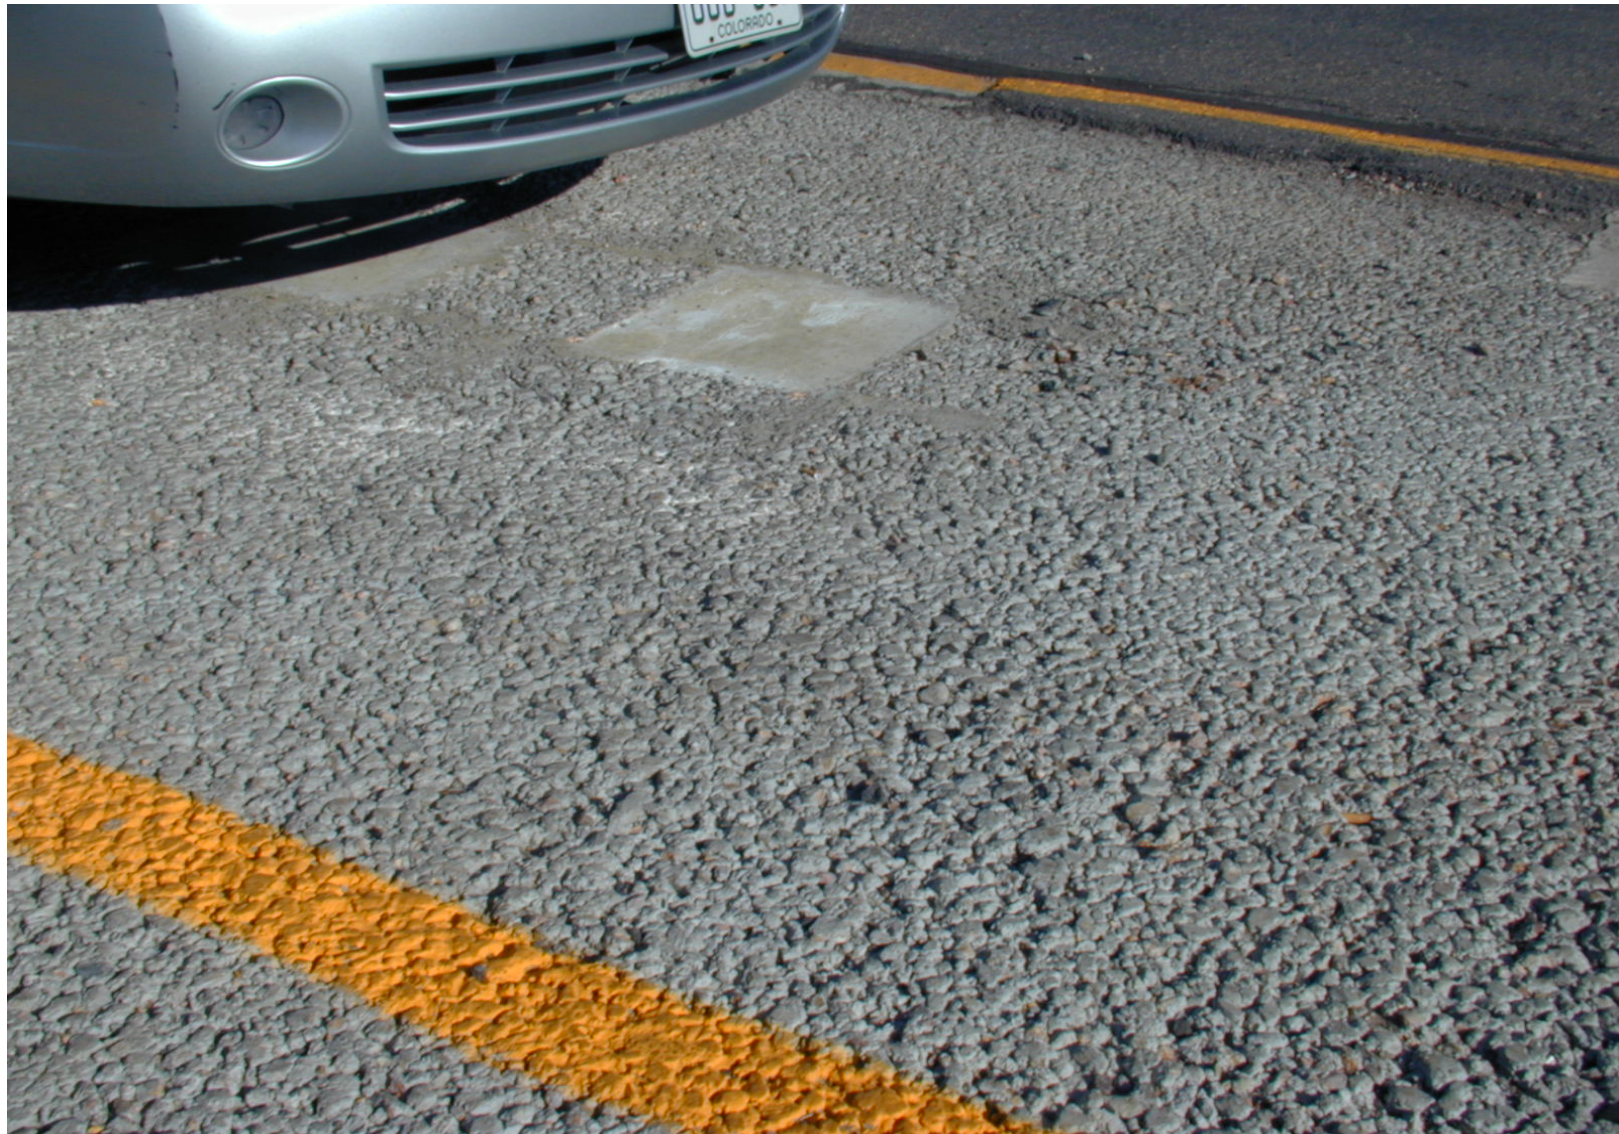
Photo 6 Site D - non distressed pervious concrete.

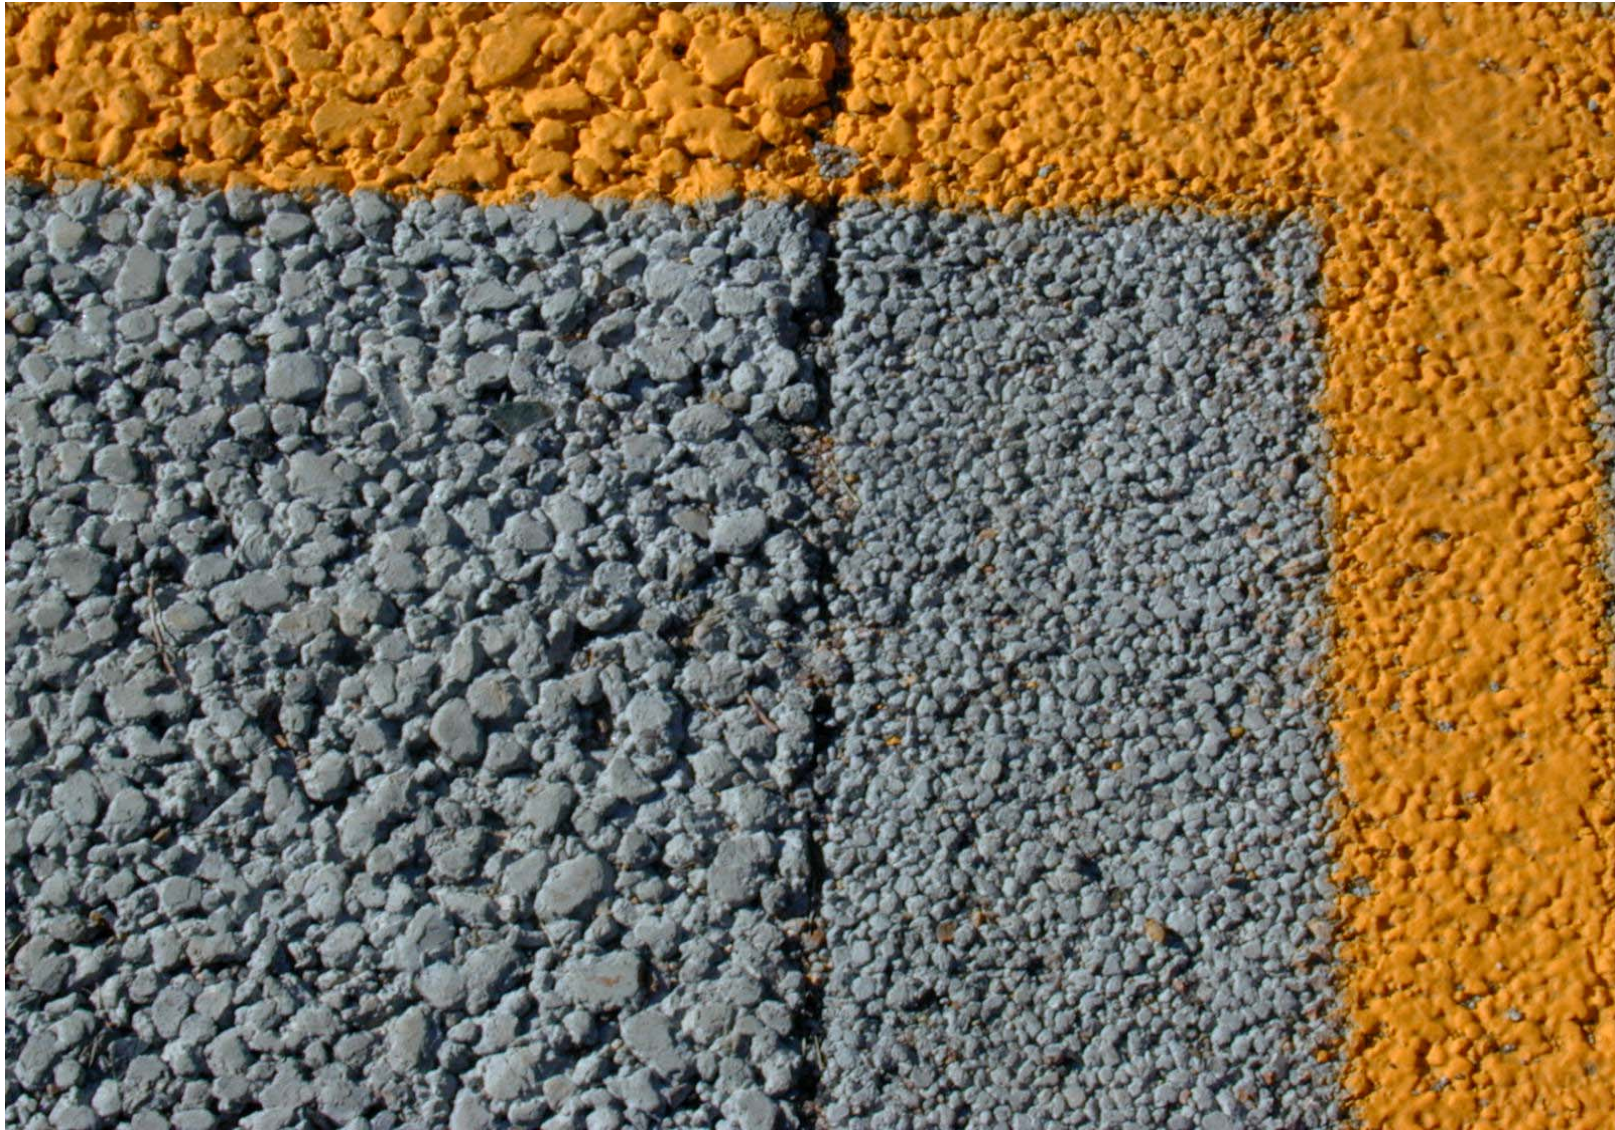
Site A is the control site for this evaluation. The pervious concrete was not displaying any significant distress or deterioration at the time of our investigation.

Photo 7 Site A - non distressed pervious concrete.

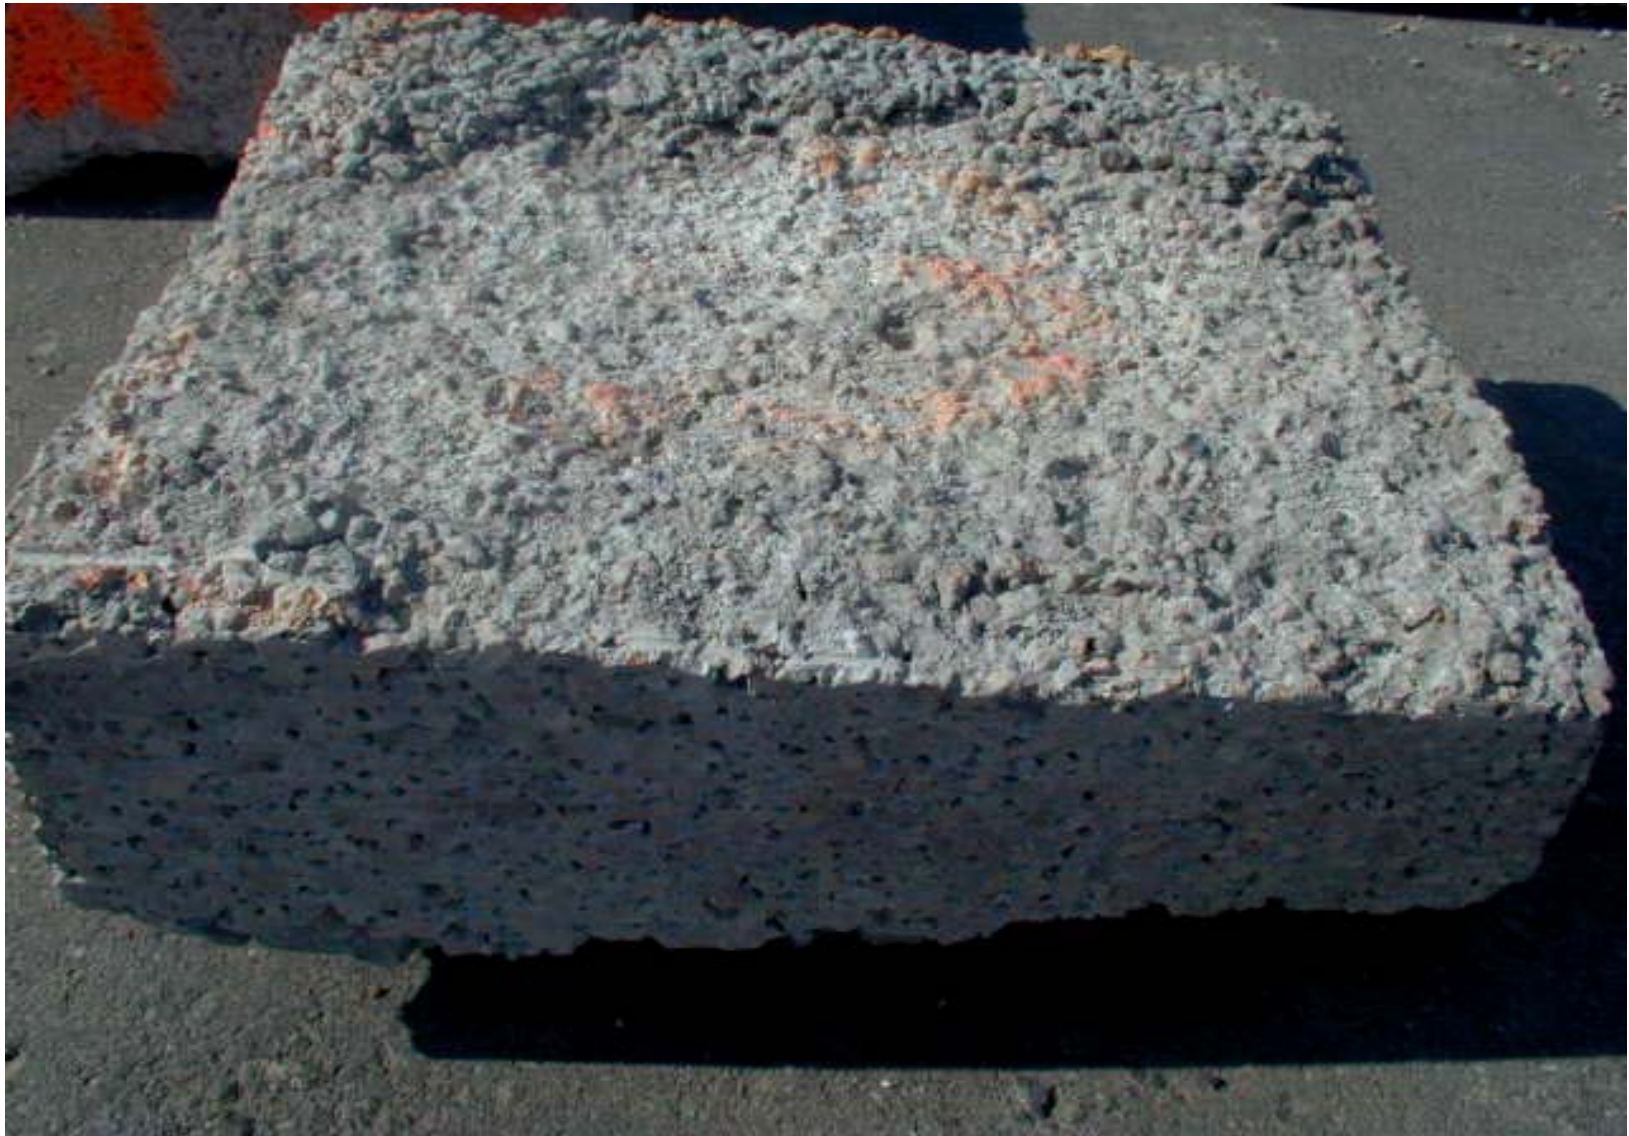
Photo 8 Site A - two different in-place pervious concrete mixes.

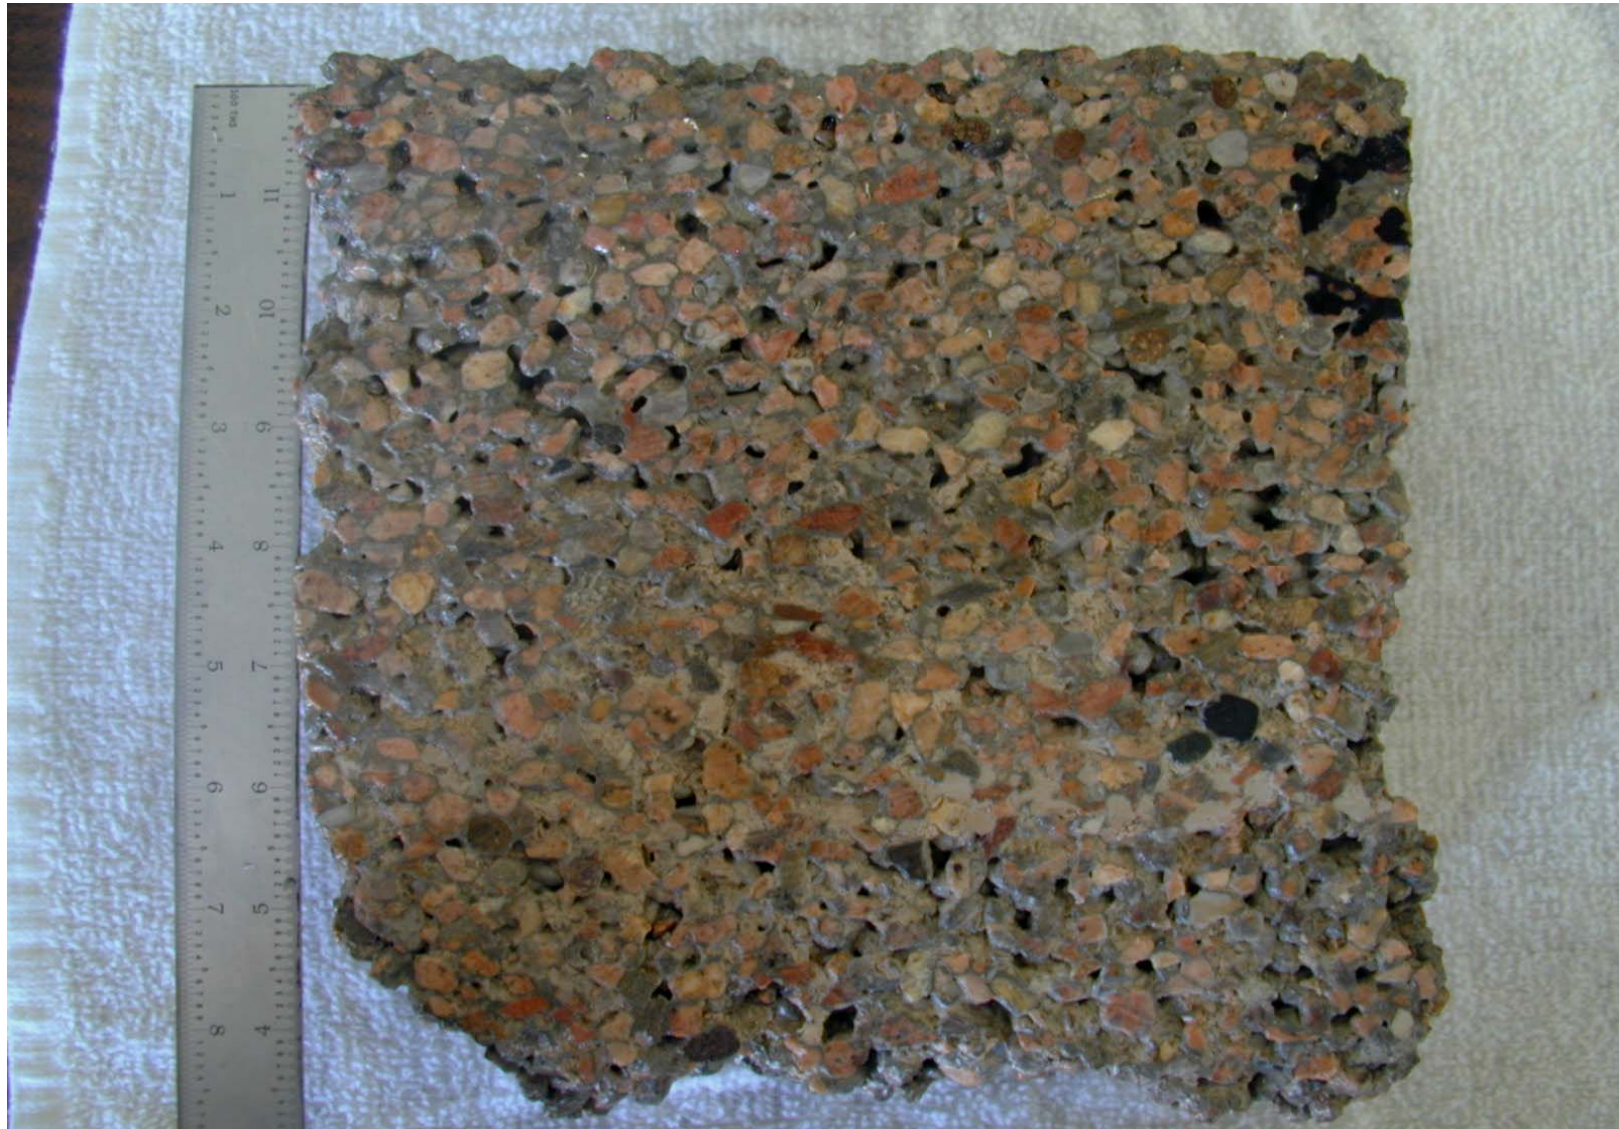
Photo 10 Site B - sample B-1 (distressed sample).

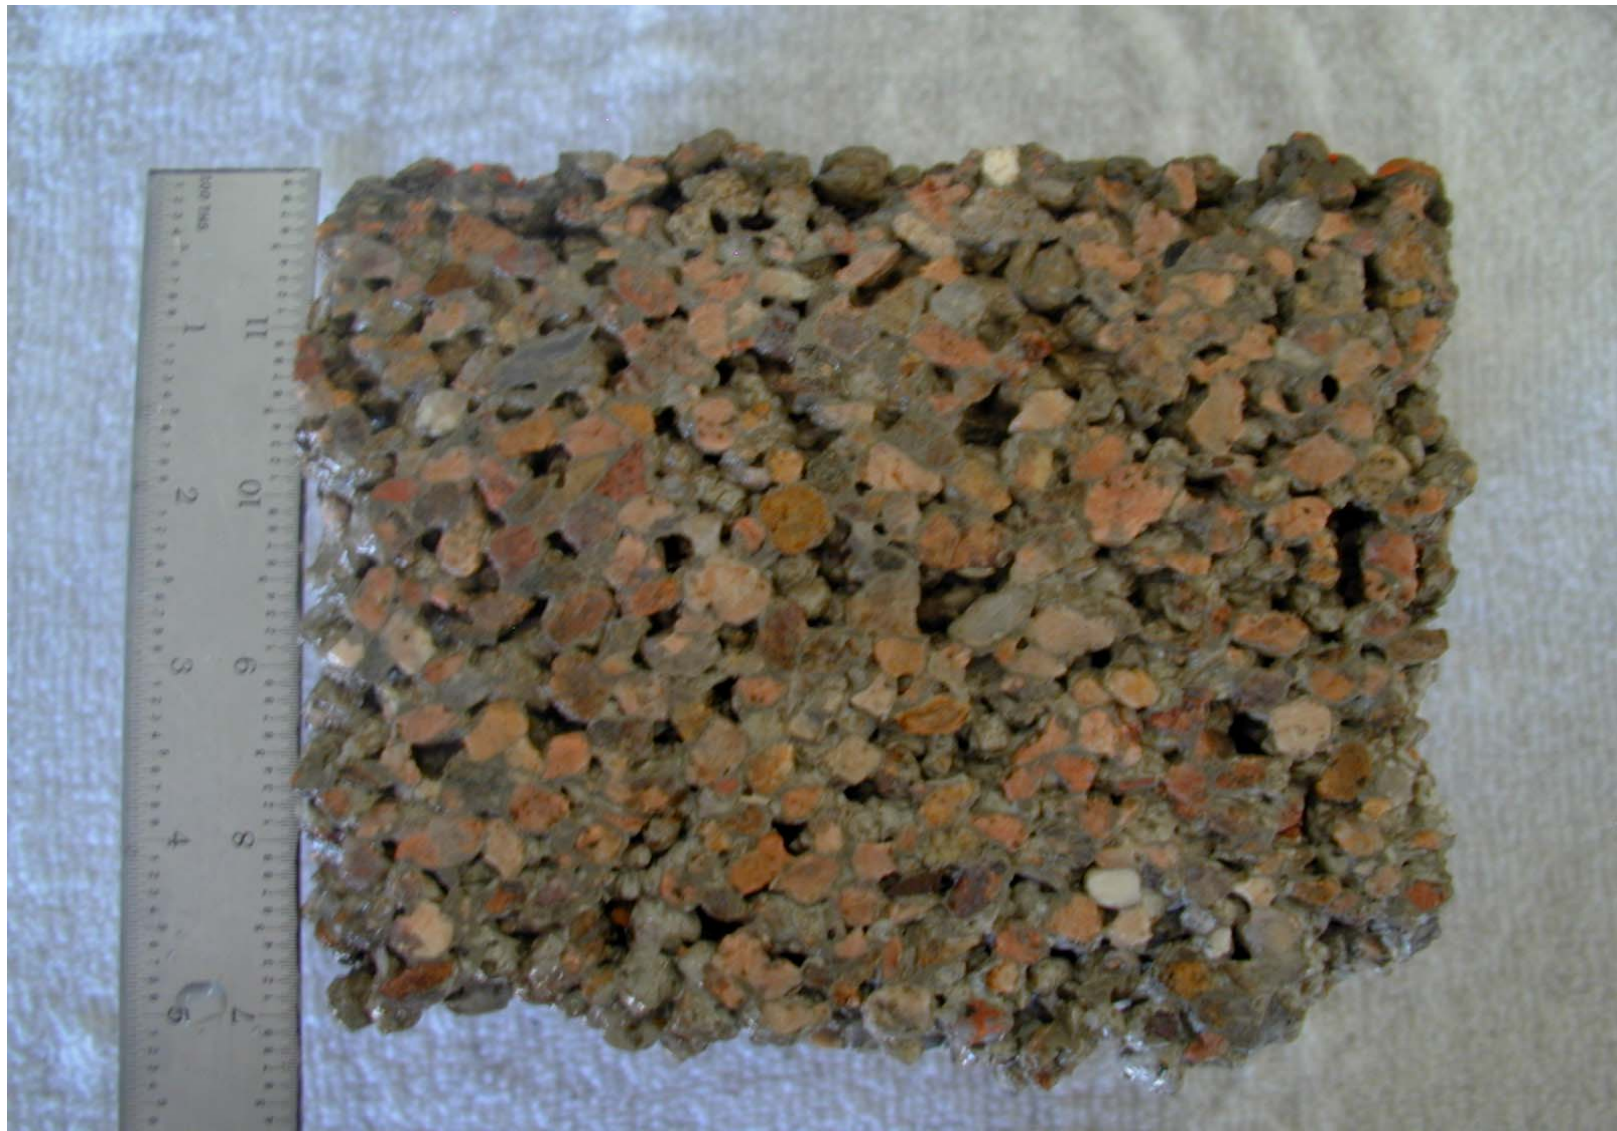
Photo 11 Site B - sample B-4 (non distressed sample).

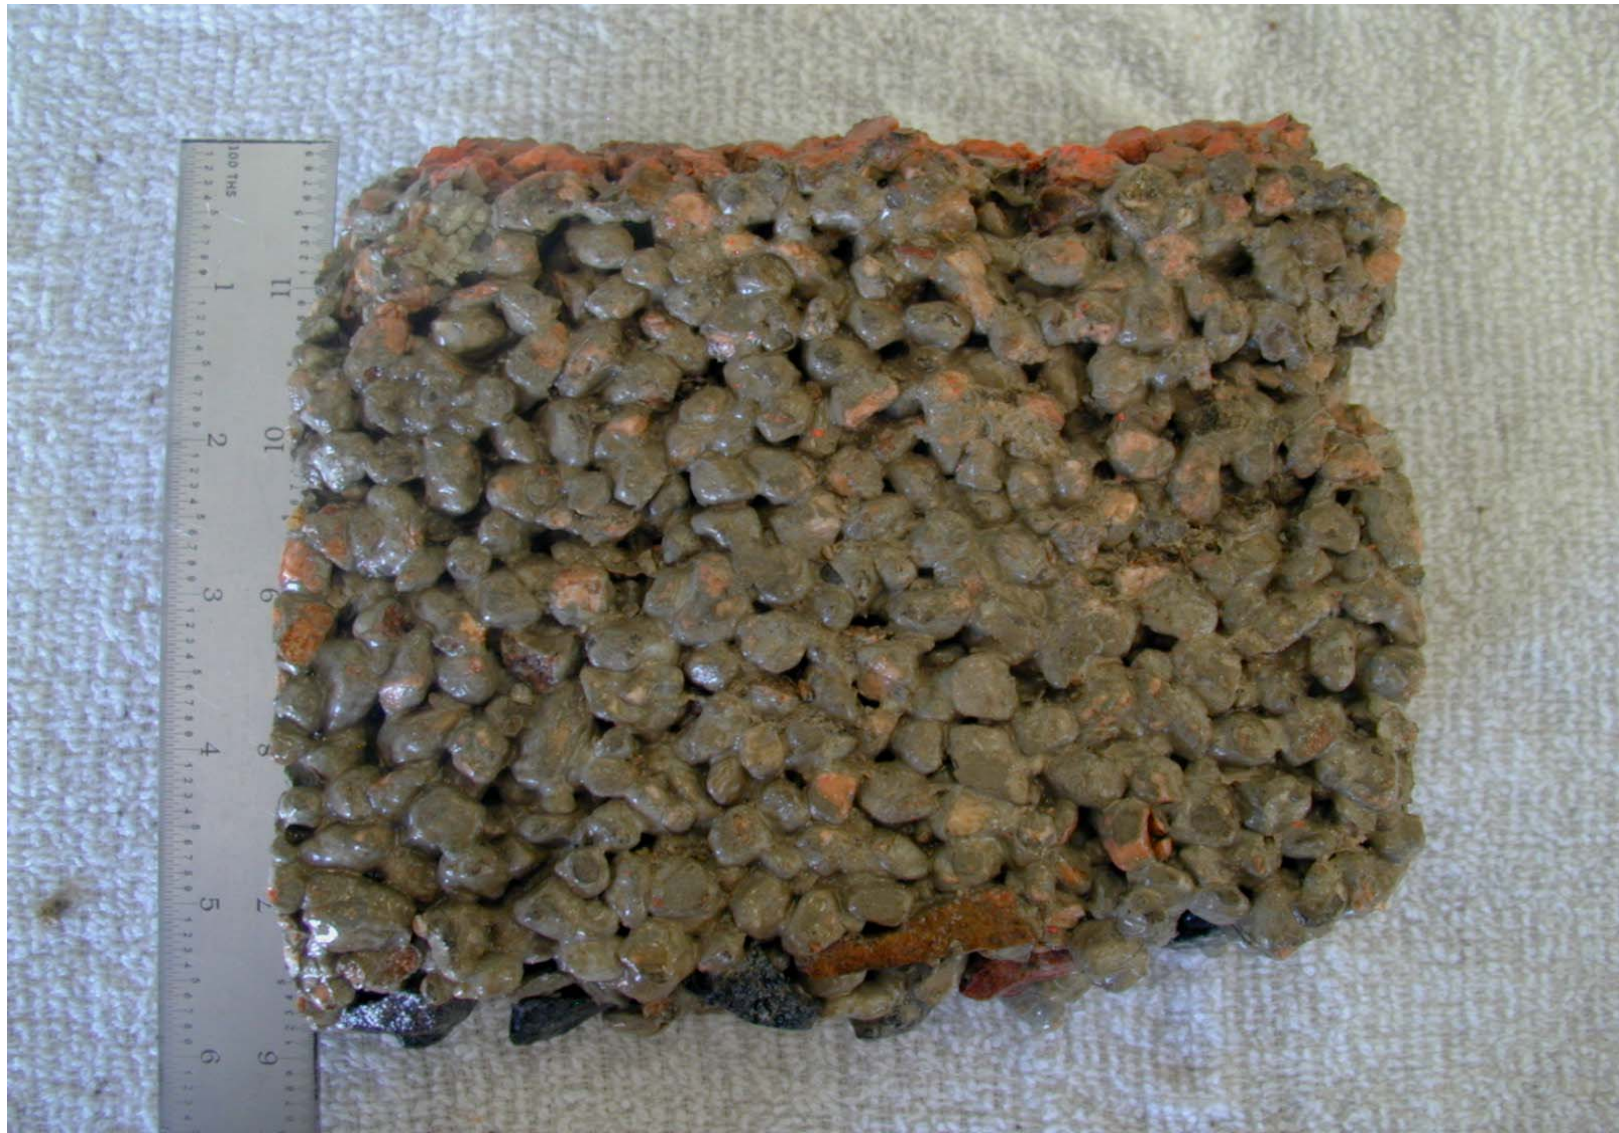
Photo 12 Site C - sample C-3 (distressed sample).

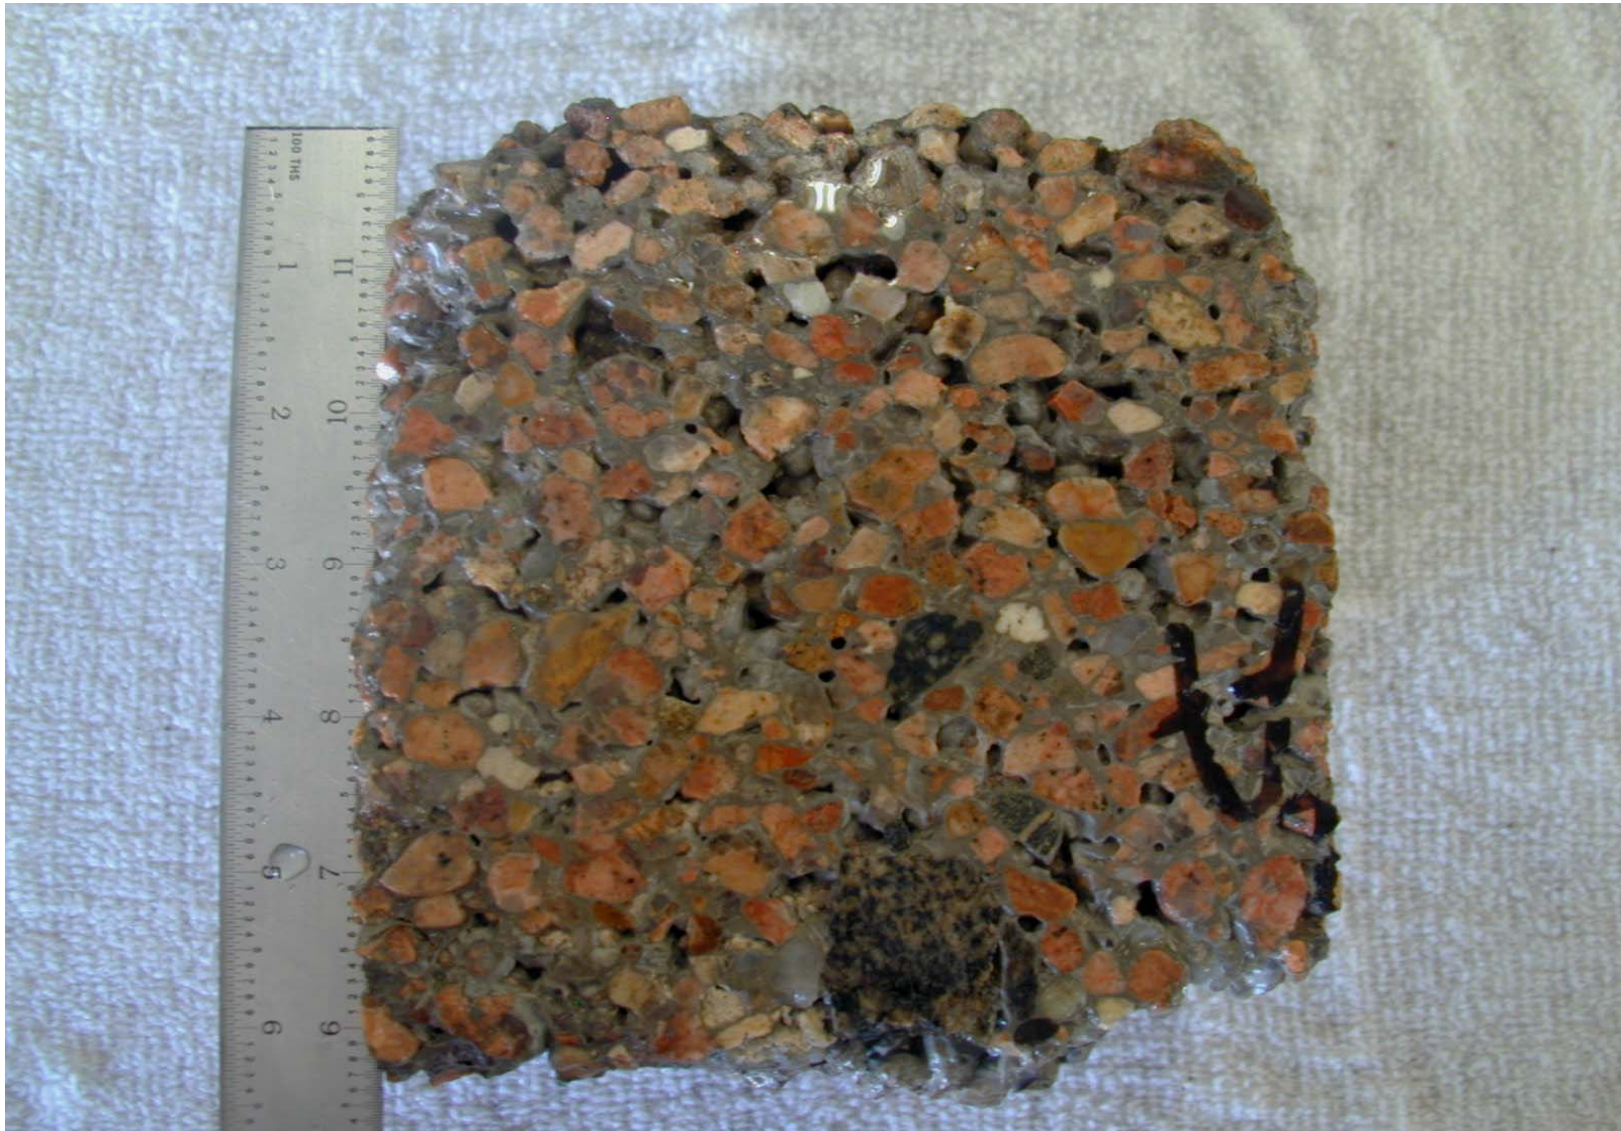
Photo 13 Site C - sample C-4 (non distressed sample).
