**PERVIOUS CONCRETE EVALUATION
MATERIALS INVESTIGATION
DENVER, COLORADO**

**URBAN DRAINAGE AND FLOOD CONTROL DISTRICT
2480 West 26th Avenue
Suite #156-B
Denver, Colorado**

Project No. CT14,571-356

November 6, 2008

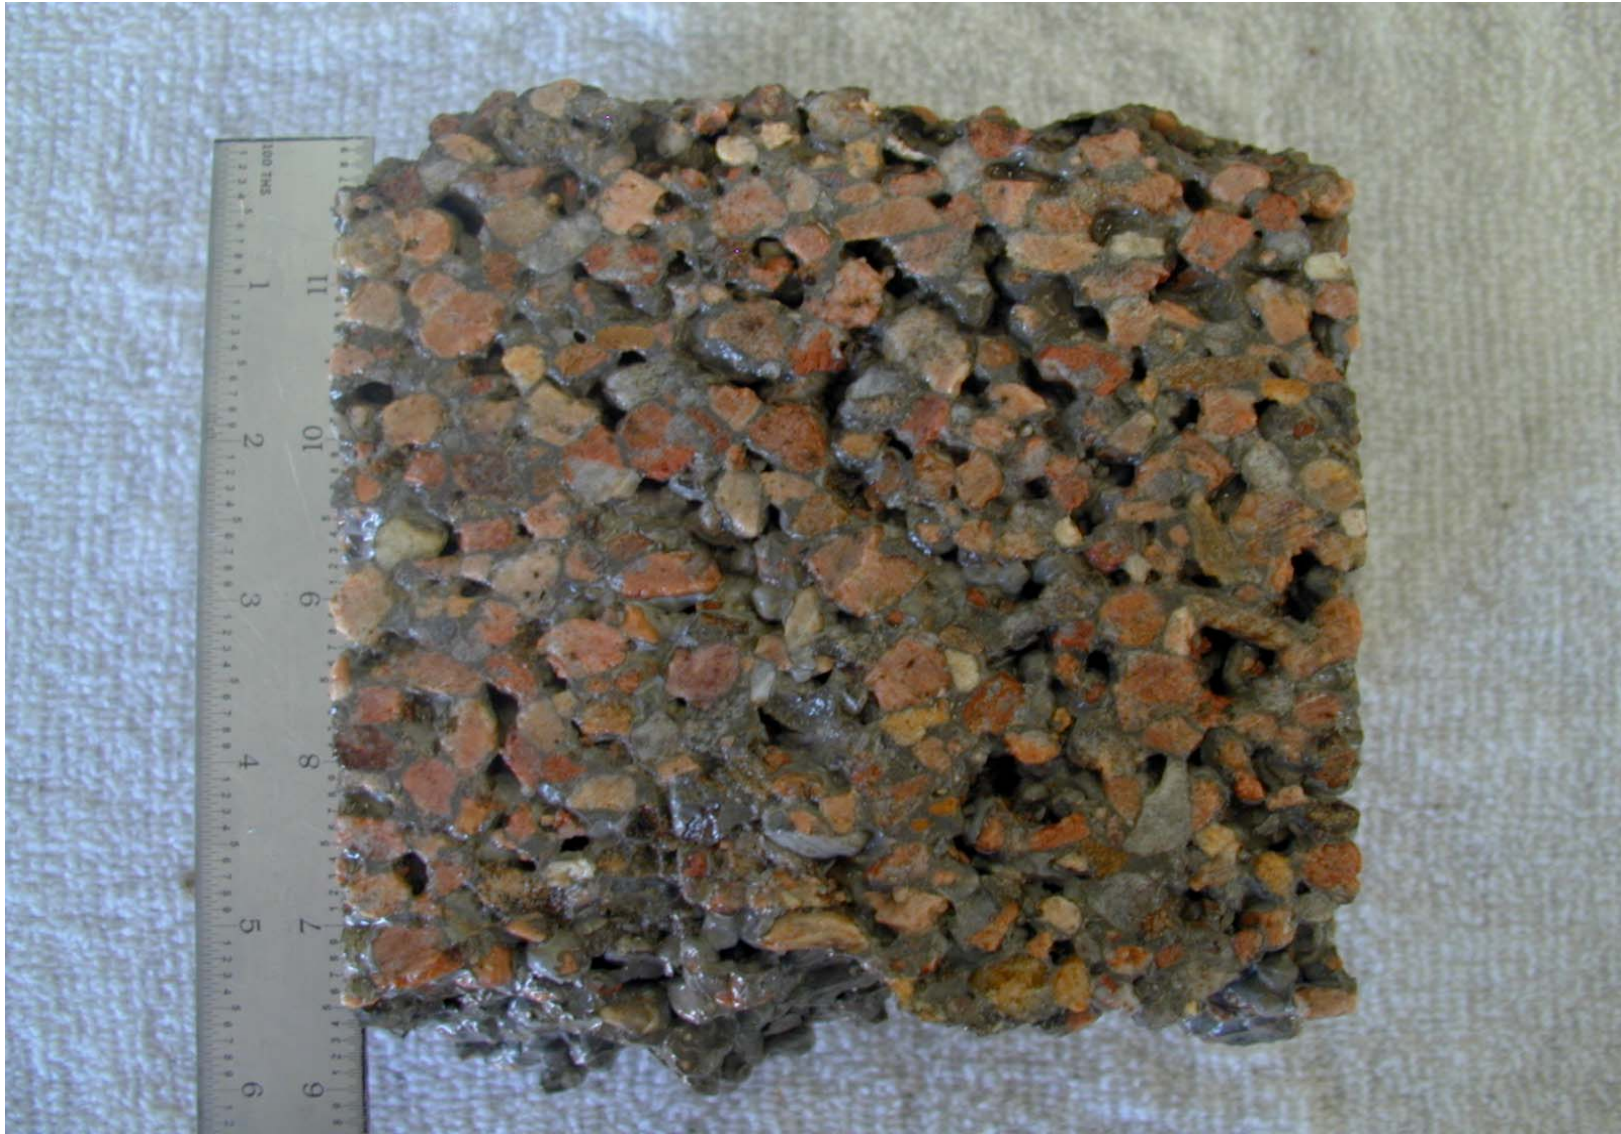
Photo 14 Site D - sample D-1 (distressed sample).

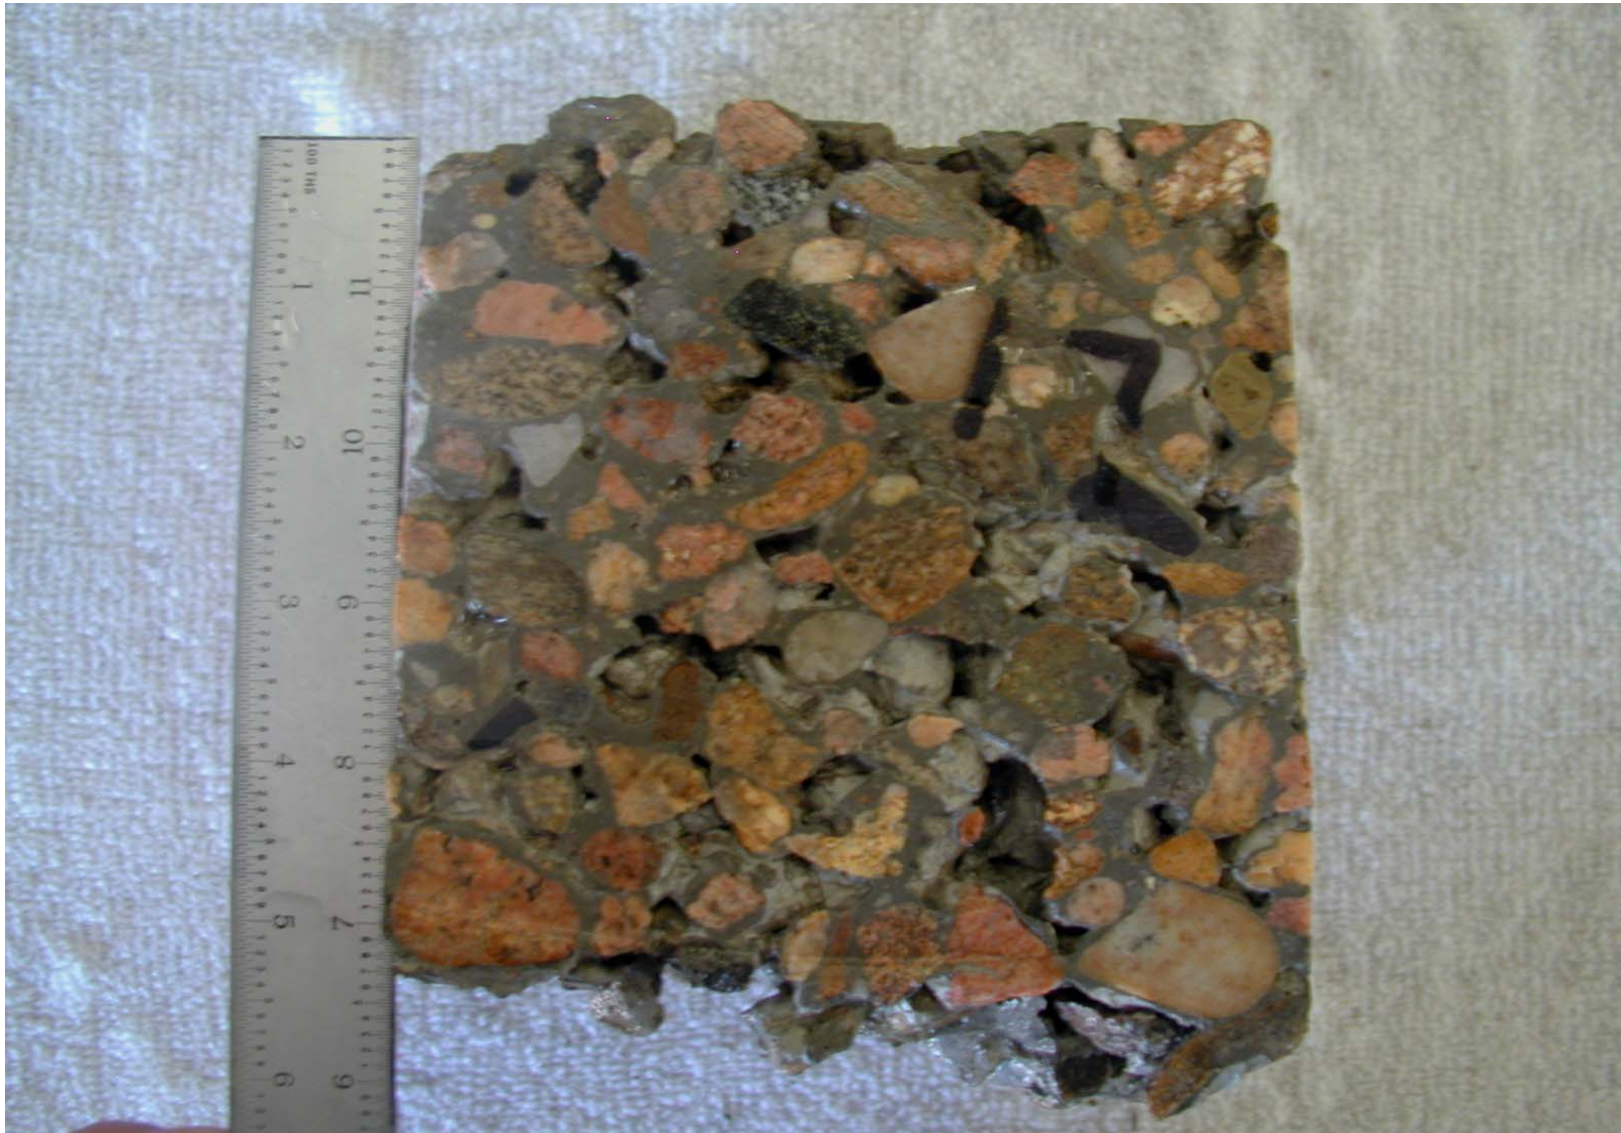
Photo 15 Site D - sample D-4 (non distressed sample).

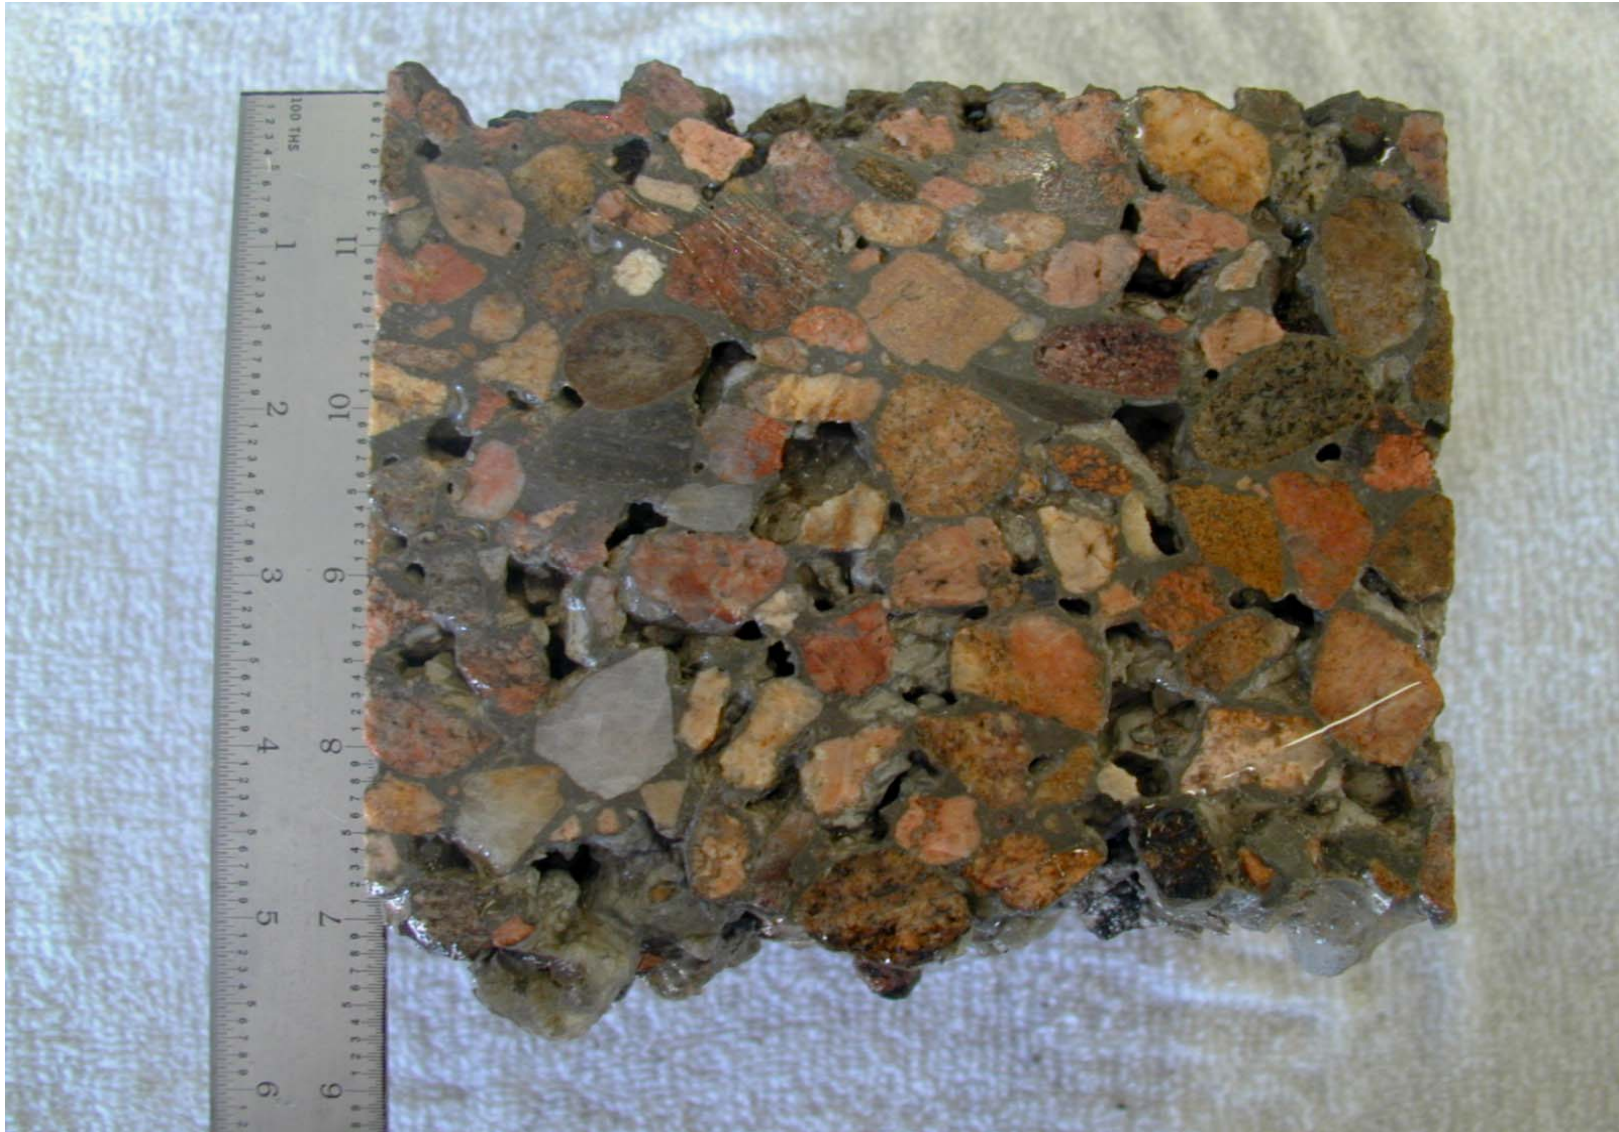
Photo 16 Site A - sample A-1 (non distressed sample).

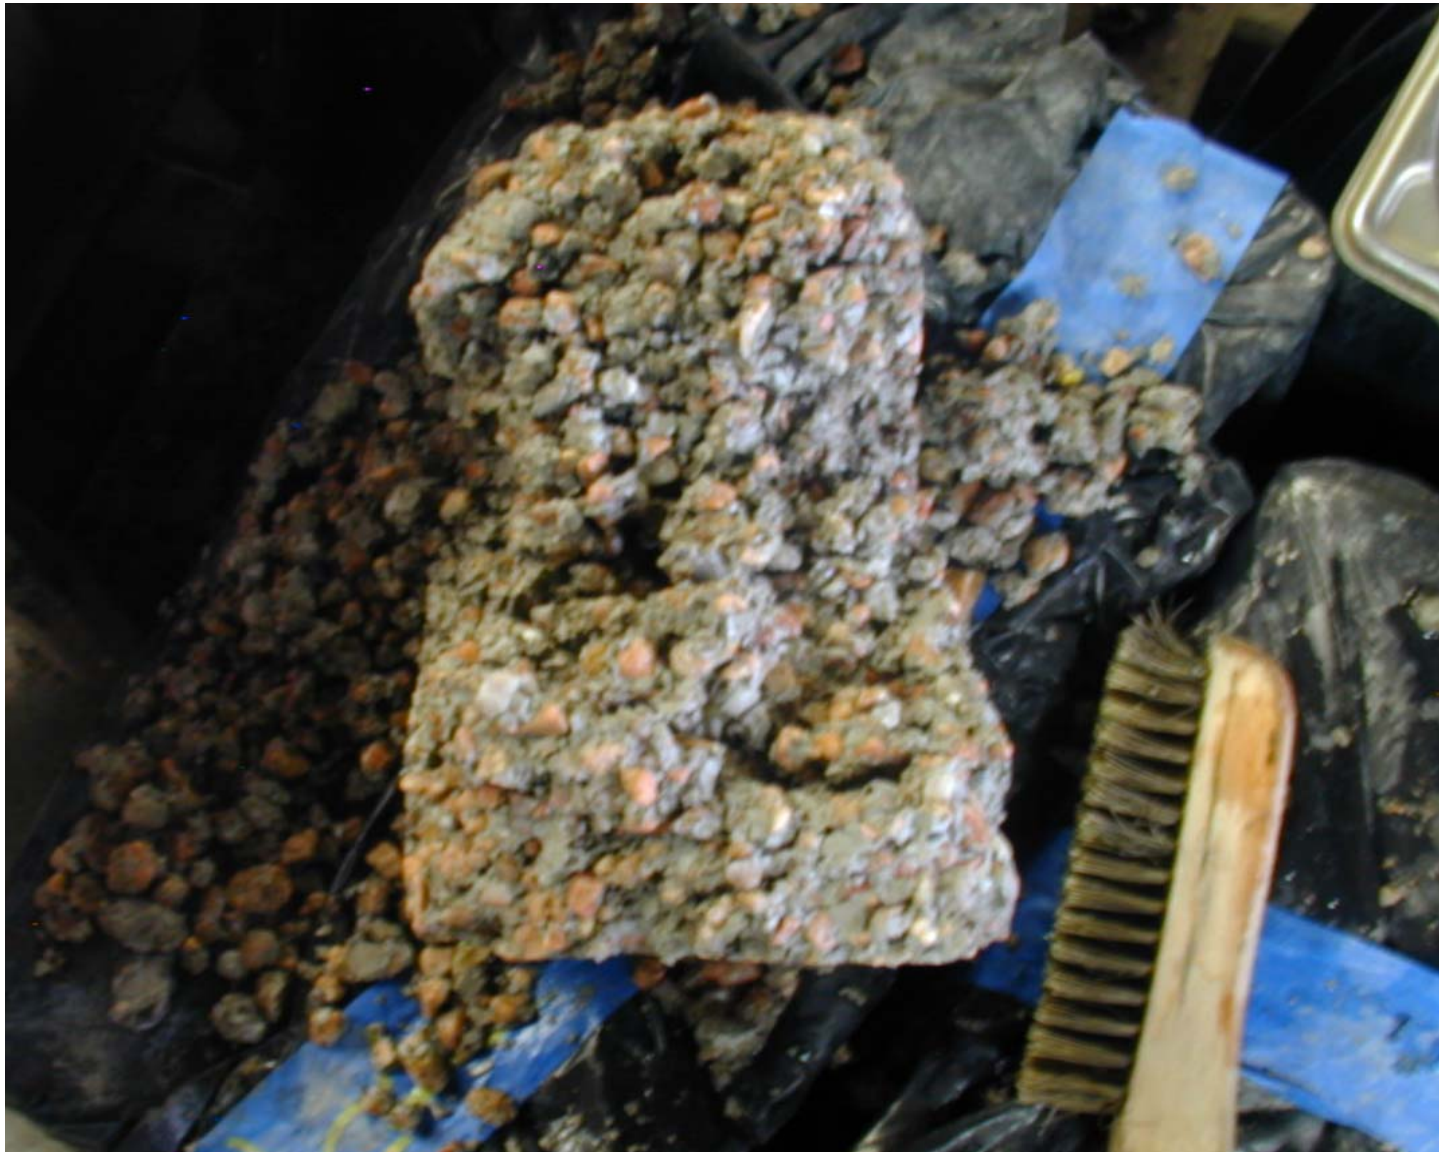
Photo 17 Site A - sample A-3 (non distressed sample).

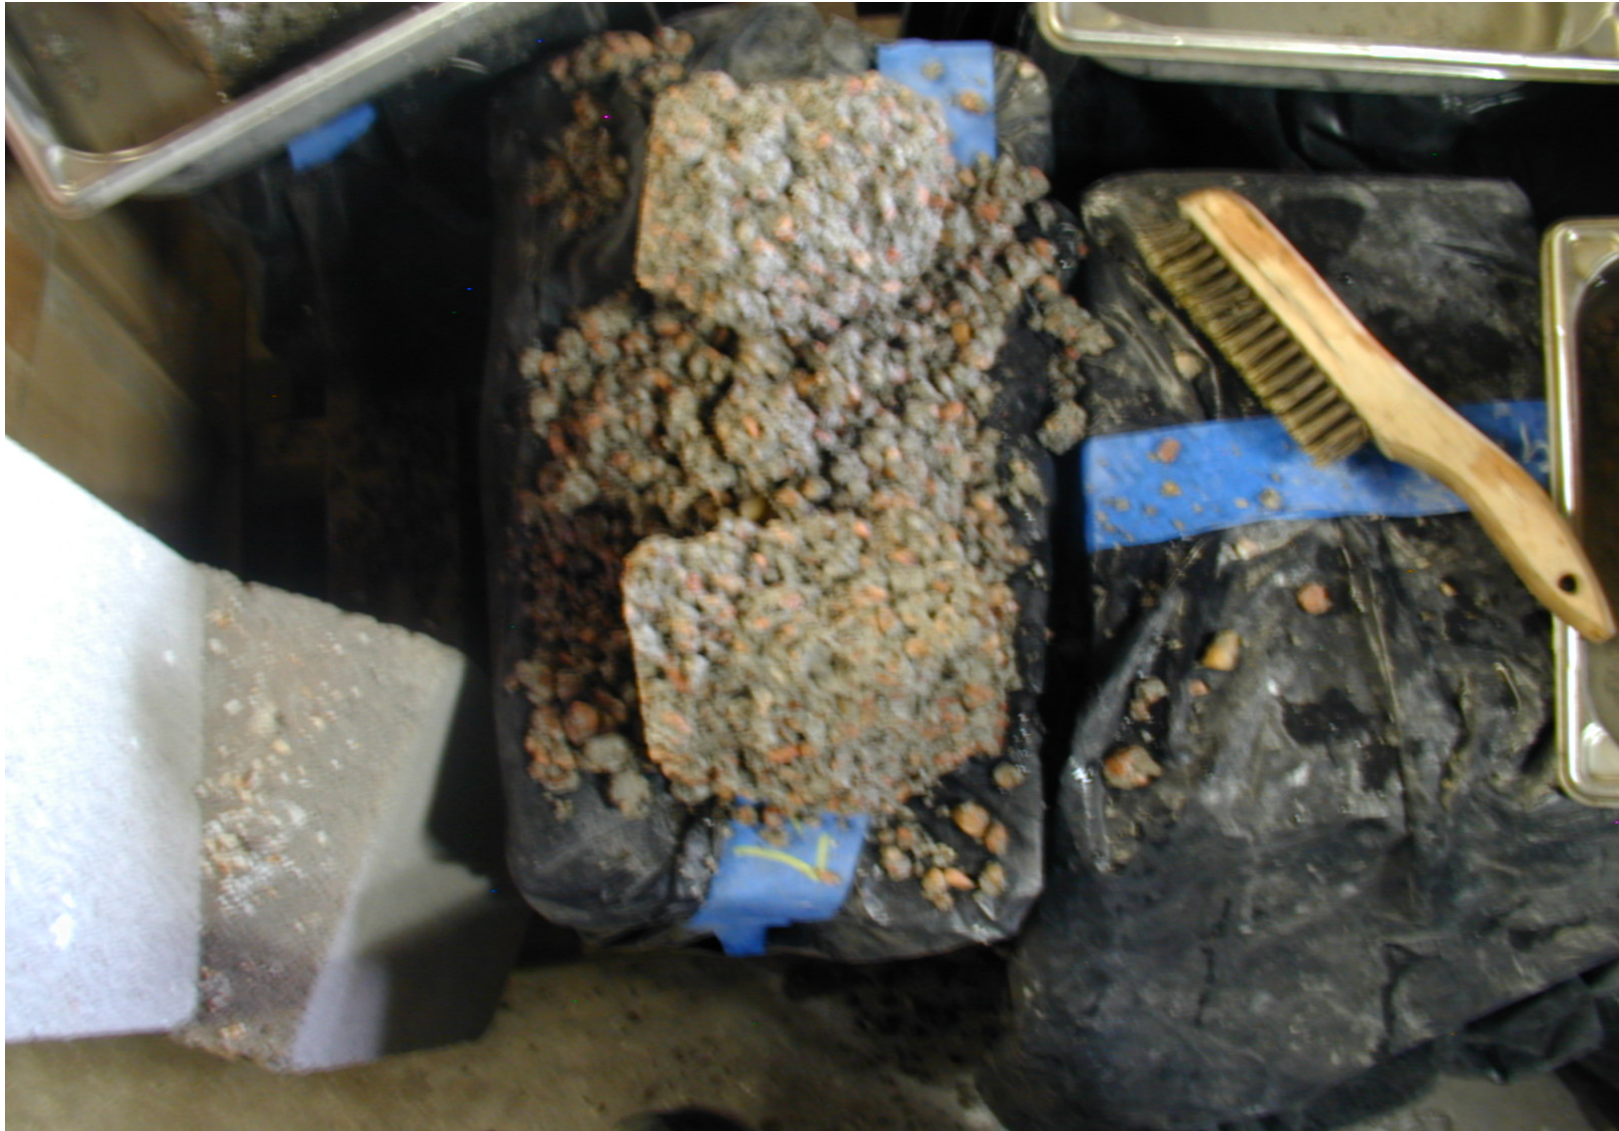
Four samples were was subjected to freeze-thaw abrasion durability testing (modified ASTM D560 and ASTM D559) for a total of 50 cycles. The mass of the sample was tracked during testing to measure percent loss over the testing period (Photos 18-20). All four samples exhibited complete failure after 6 to 41 cycles (Table III).

Photo 18 Deterioration of samples during freeze-thaw testing.

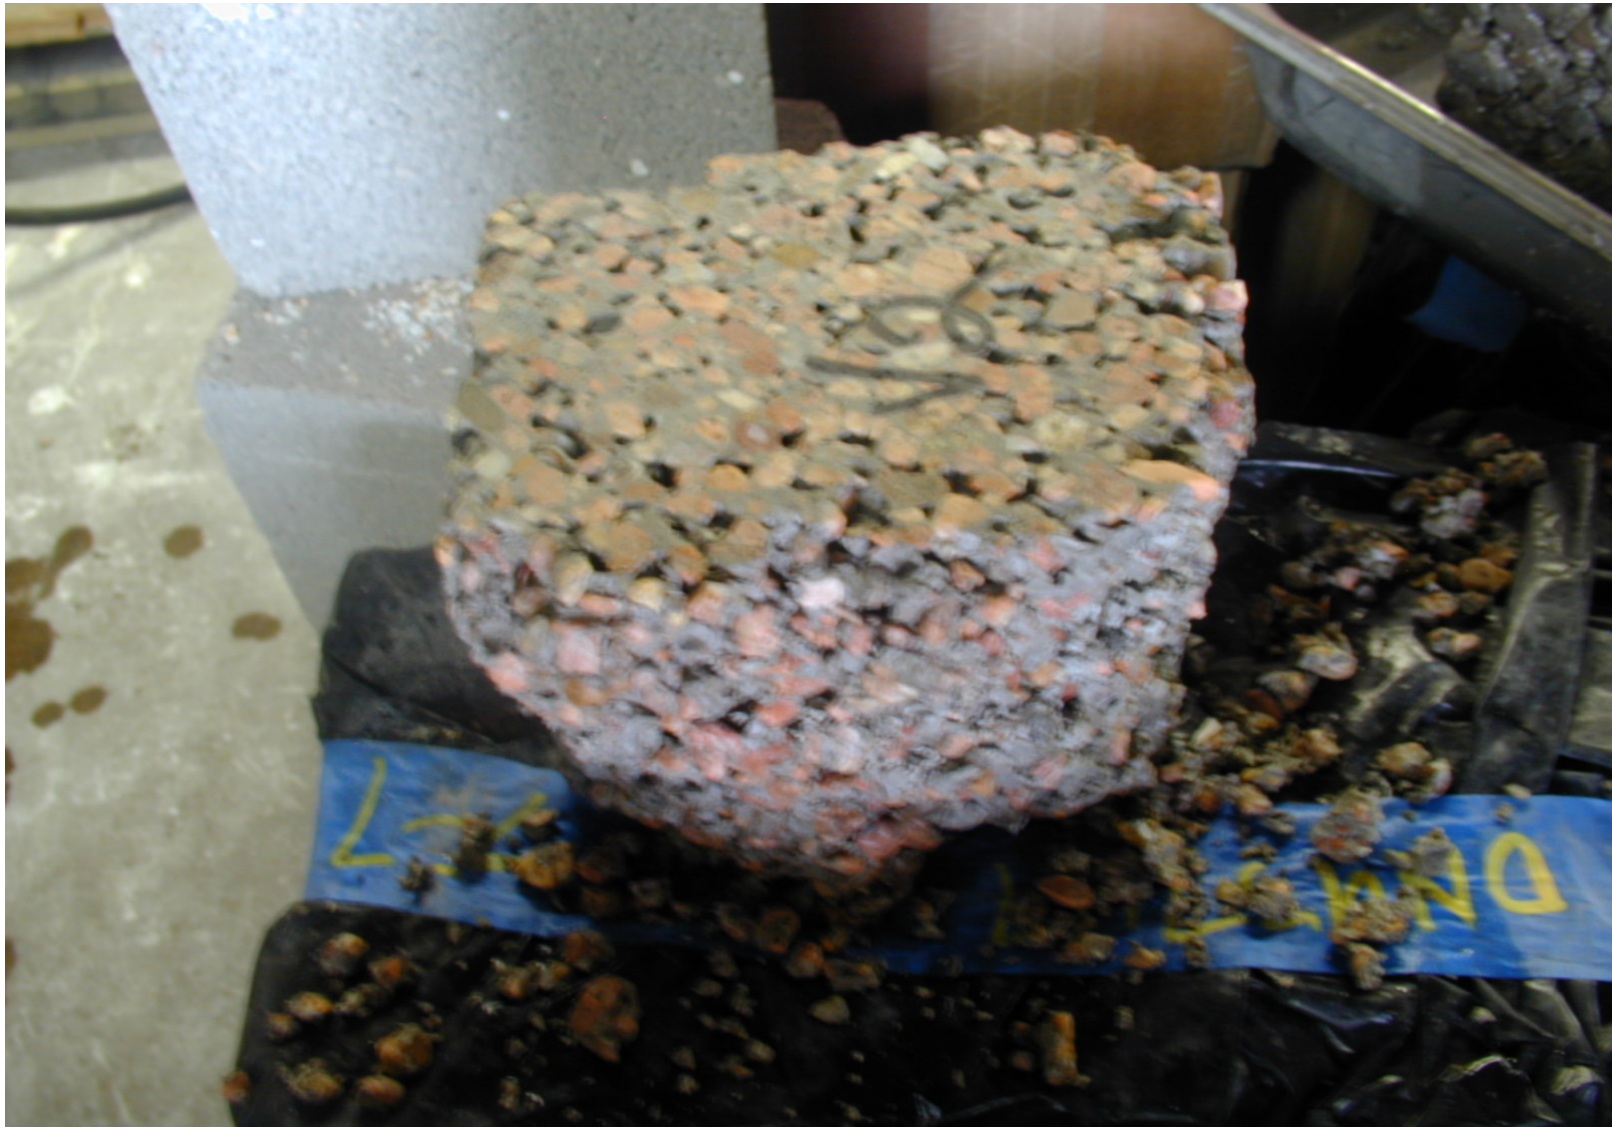
Photo 19 Deterioration of samples during freeze-thaw testing.

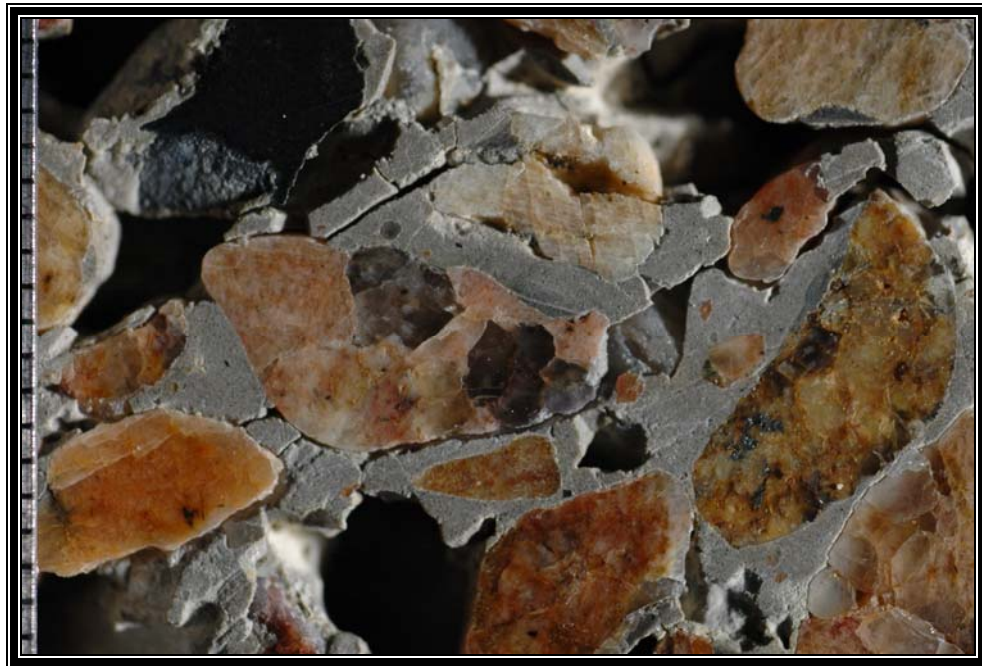
3. CRACKING	
MACROSCOPIC	In the as-received block no macroscopic cracks were observed. Sub-horizontal cracks are present in the top 50 mm (2 in.); these cracks are sites of the aggregate tears and crumbling during sample preparation (Figure A3). These cracks are similar to adhesion cracks and wrap around aggregate particles.
MICROSCOPIC	Frequent microcracking is observed in the top 50 mm (2 in.) where the microcracks show no preferred orientation (Figure A4). Most of the microcracks are less than 50 µm (2 mil) wide and up to 9.5 mm (¾ in.) long. The deposits are mostly free of secondary deposits but occasional cracks are filled with calcium carbonate or lined with ettringite along segments of the microcrack.

Figure A3. (a) Photograph showing cracks in the paste near the top surface; scale in millimeters.

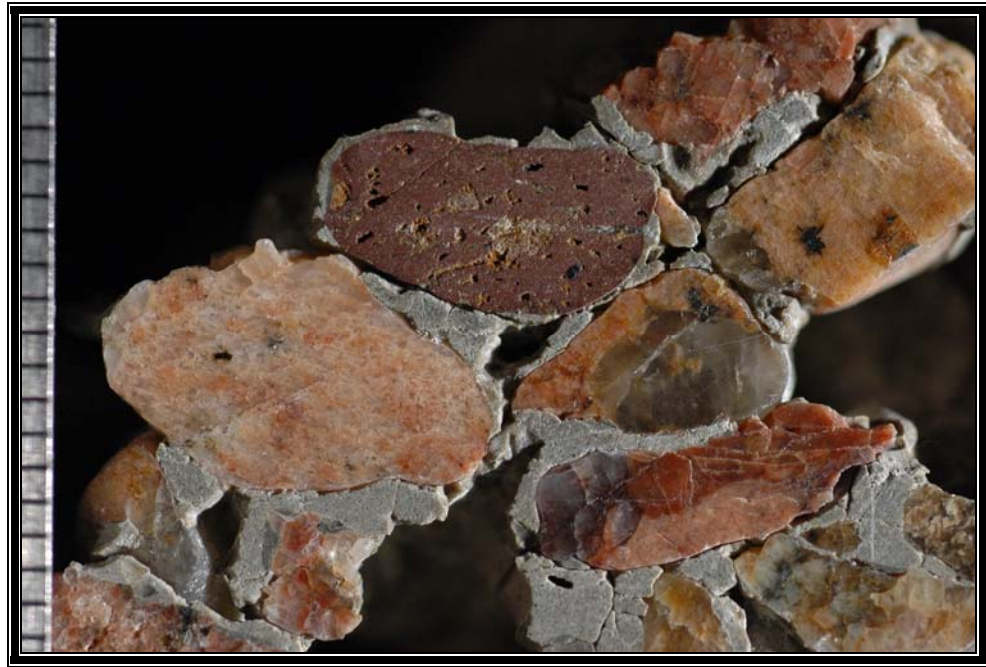
Figure A3 (cont'd). (b) Photograph showing cracks in the paste near the top surface; scale in millimeters.

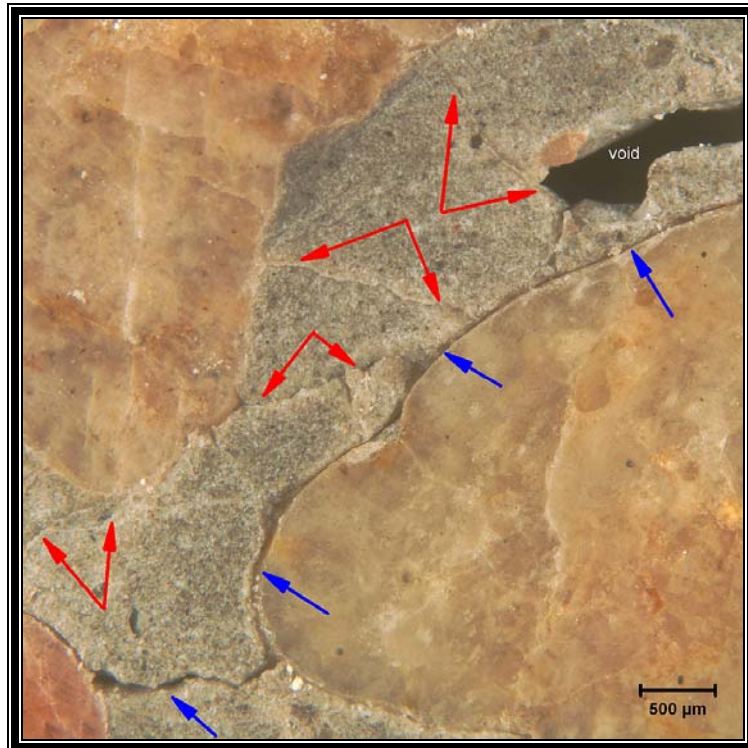
Figure A4. Reflected light photomicrograph showing microcracks (red arrows) and crack near the top of the slab.

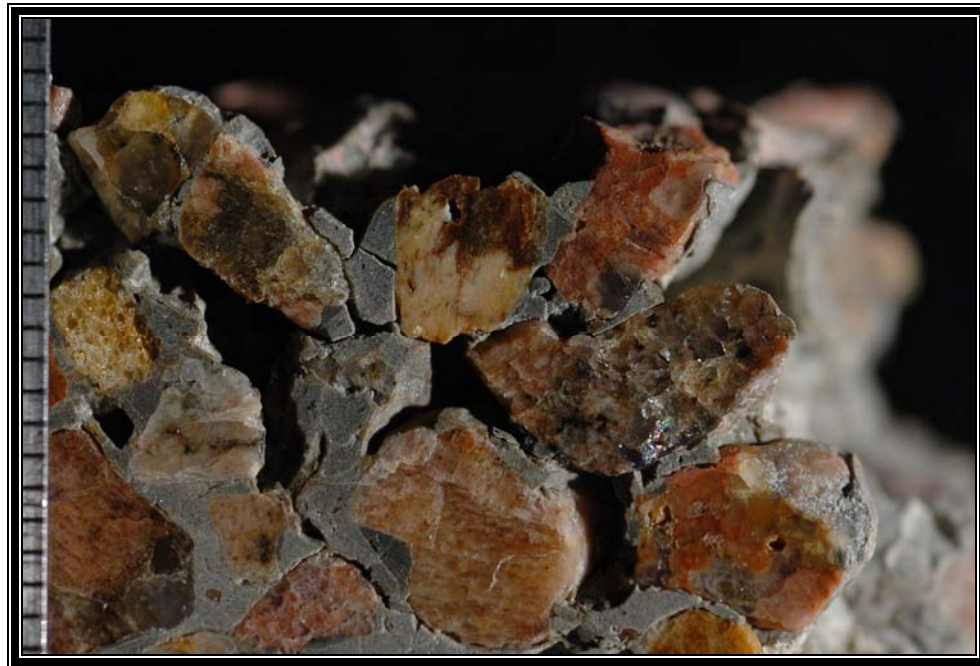
3. CRACKING	
MACROSCOPIC	Occasional sub-horizontal cracks and adhesion cracks are present in the top 38-50 mm (1 ½-2 in.). These cracks are up to 100 µm (4 mil) wide and 9.5 mm (¾ in.) long and cut exclusively around aggregate particles (Figure B3).
MICROSCOPIC	Frequent microcracking is observed in the top 38-50 mm (1 ½-2 in.) where the microcracks show no preferred orientation. Most of the microcracks are less than 50 µm (2 mil) wide and up to 9.5 mm (¾ in.) long. The deposits are mostly free of secondary deposits but occasional cracks are filled with calcium carbonate or lined with ettringite along segments of the microcrack. Randomly oriented microcracks measuring 25-50 µm (1-2 mil) wide are common in the lower portion of the core (Figure B4). Some microcracking is present near the bottom of the slab but these appear related to sample extraction.

Figure B3. (a) Photograph of polished surface showing overview of cracking near the top of the slab; scale in millimeters.

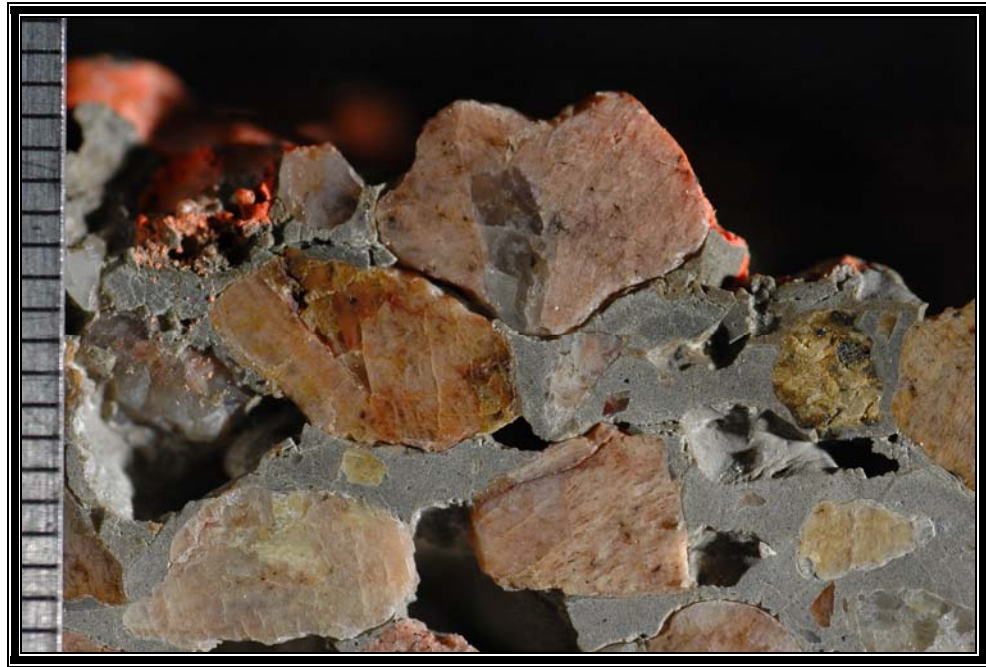
Figure B3 (cont'd). (b) Photograph of polished surface showing overview of cracking near the top of the slab; scale in millimeters.

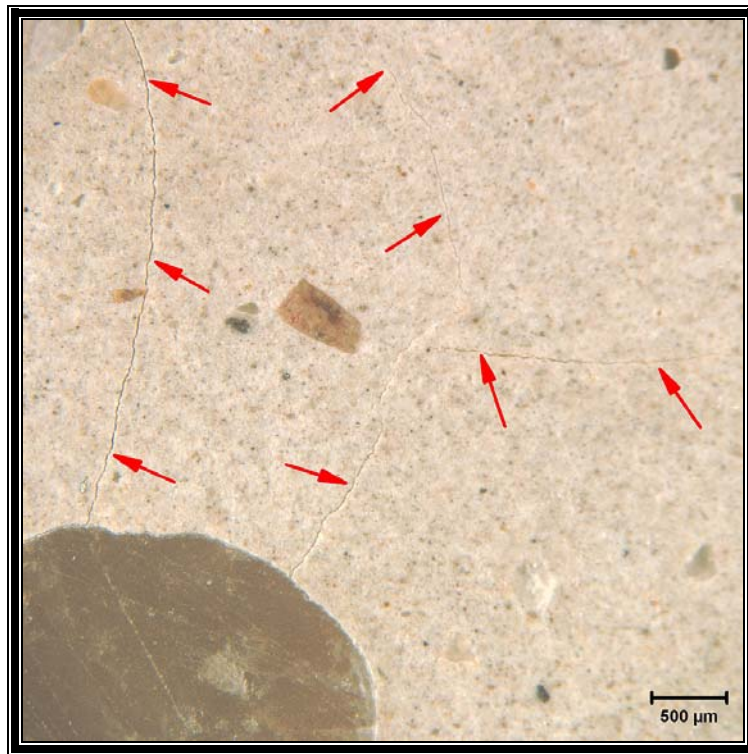
Figure B4. Reflected light photomicrographs showing microcracks (red arrows) in the central portion of the slab.
