**PERVIOUS CONCRETE EVALUATION
MATERIALS INVESTIGATION
DENVER, COLORADO**

**URBAN DRAINAGE AND FLOOD CONTROL DISTRICT
2480 West 26th Avenue
Suite #156-B
Denver, Colorado**

Project No. CT14,571-356

November 6, 2008

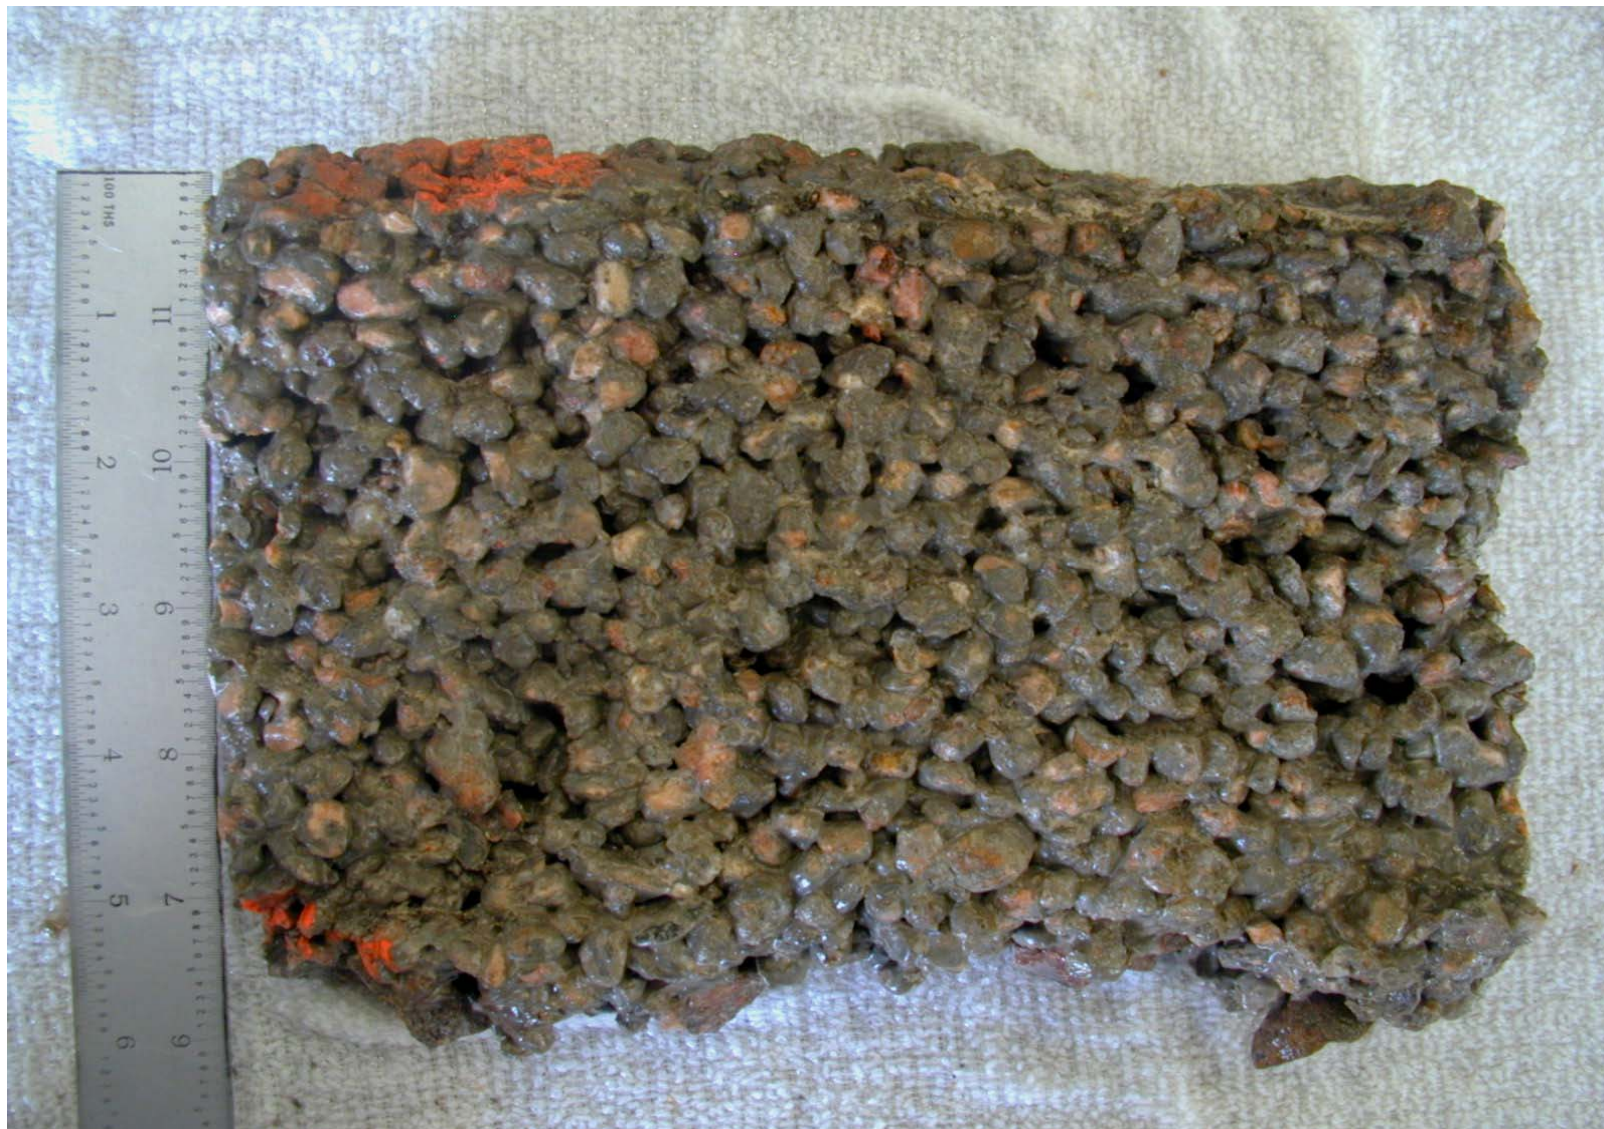
Photo 9 Saw cut samples returned to CTL Materials Lab for testing.

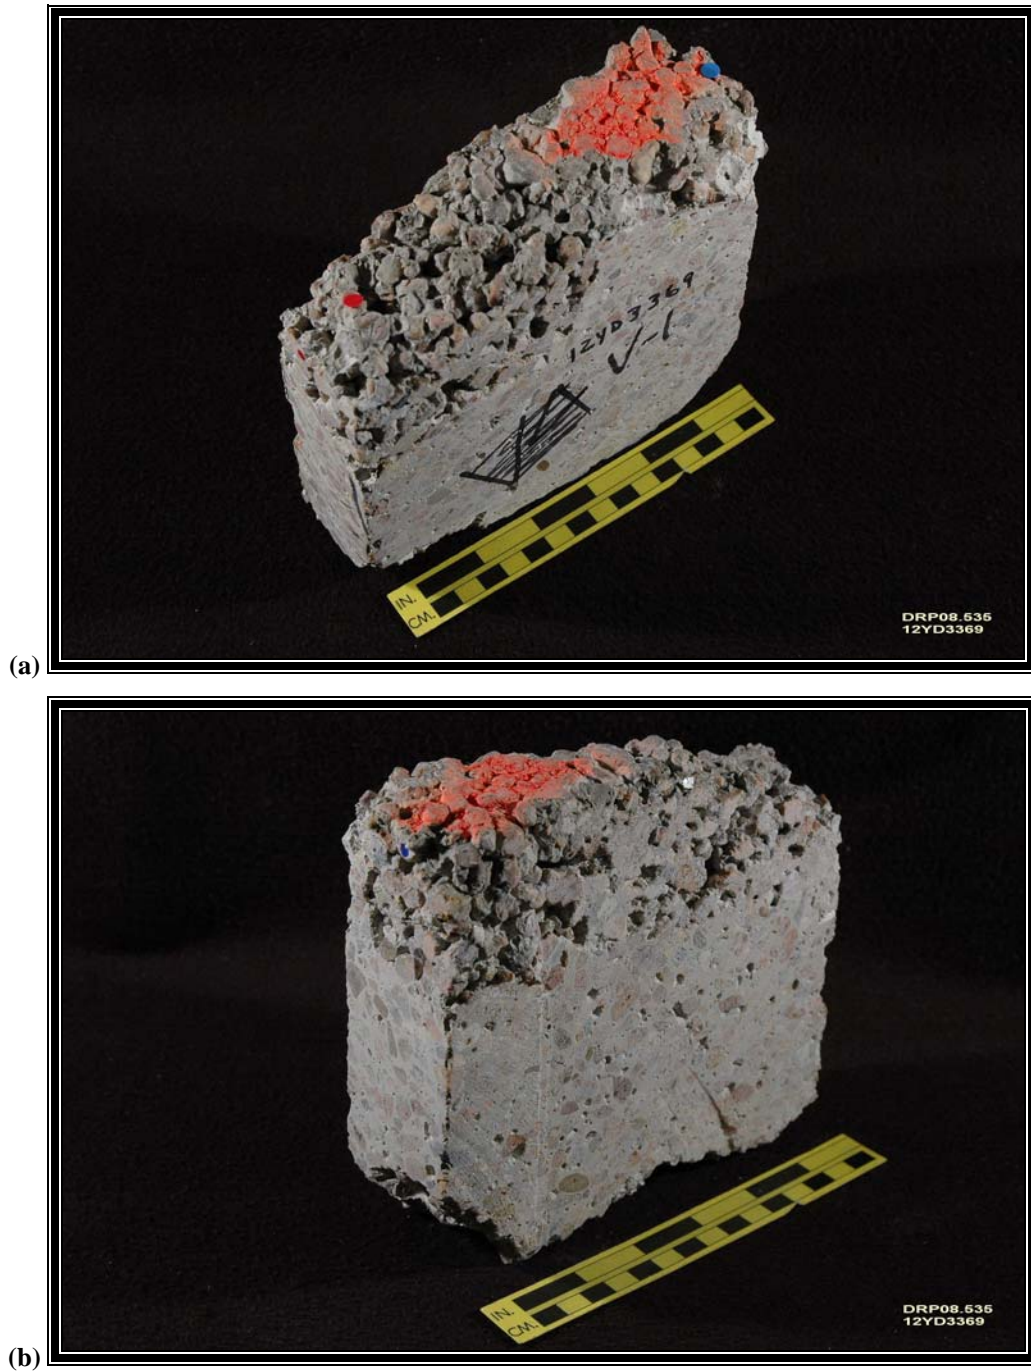
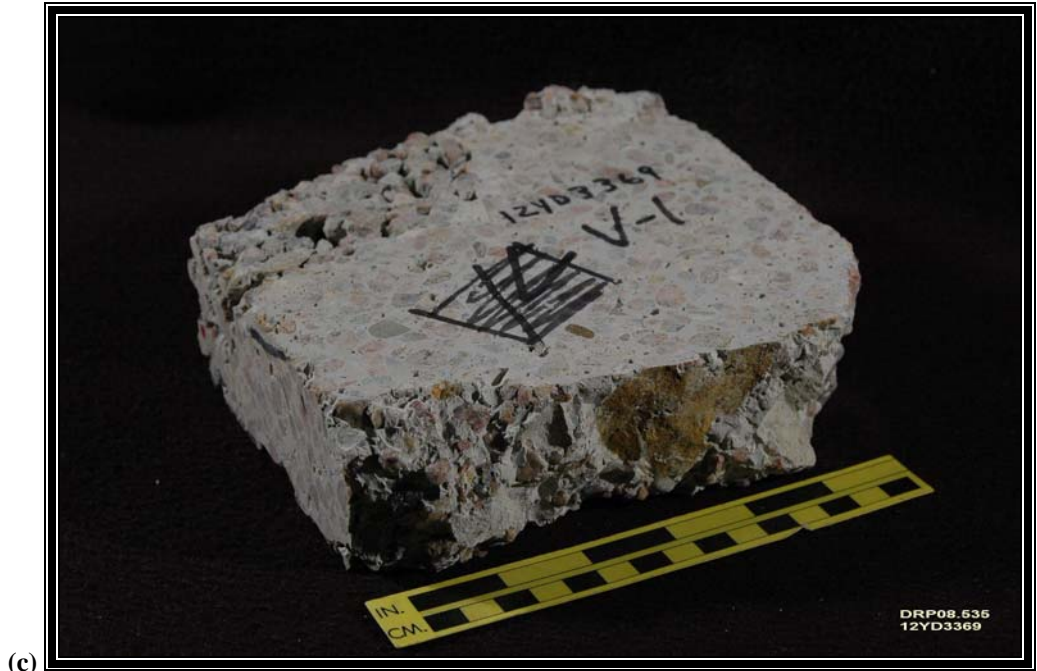
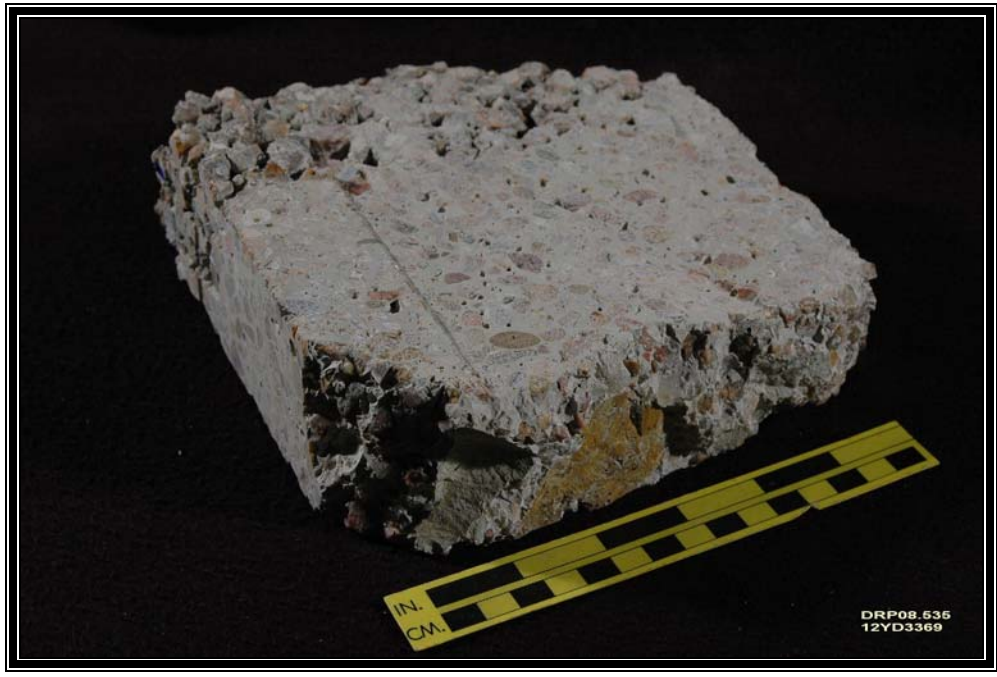
1. RECEIVED CONDITION	
ORIENTATION	Vertical block cut from concrete slab measures 160 mm (~ 6 ½ in.) long, 50 mm (~ 2 in.) wide, and 163 mm (~ 6 ½ in.) deep (Figure A1, A2).
SURFACES	Top surface has float finish; bottom surface is a fracture. The block does not represent the full thickness of the pavement.
GENERAL CONDITION	Concrete is relatively compact and hard. The material was somewhat fragile for sample preparation with aggregates dislodged easily from the top of the core. In the main body of the concrete no aggregate tears or unusual crumbling was reported.

Figure A1. Photographs of sample in as-received condition. The paint marks the top surface and the red and blue dots show the orientation of the saw cut.

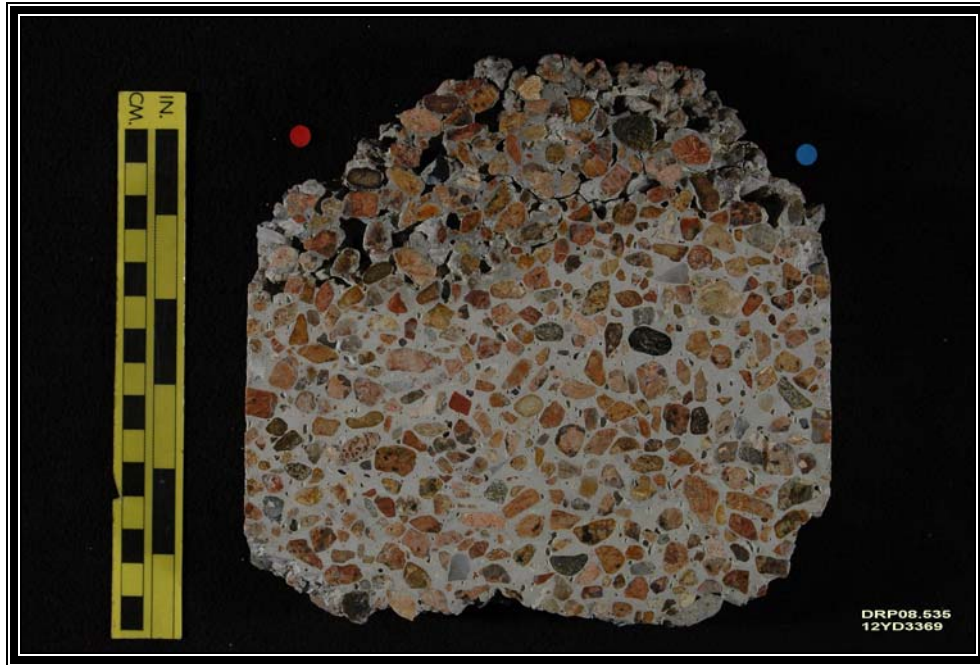
Figure A2. Photograph of polished surface of sample.

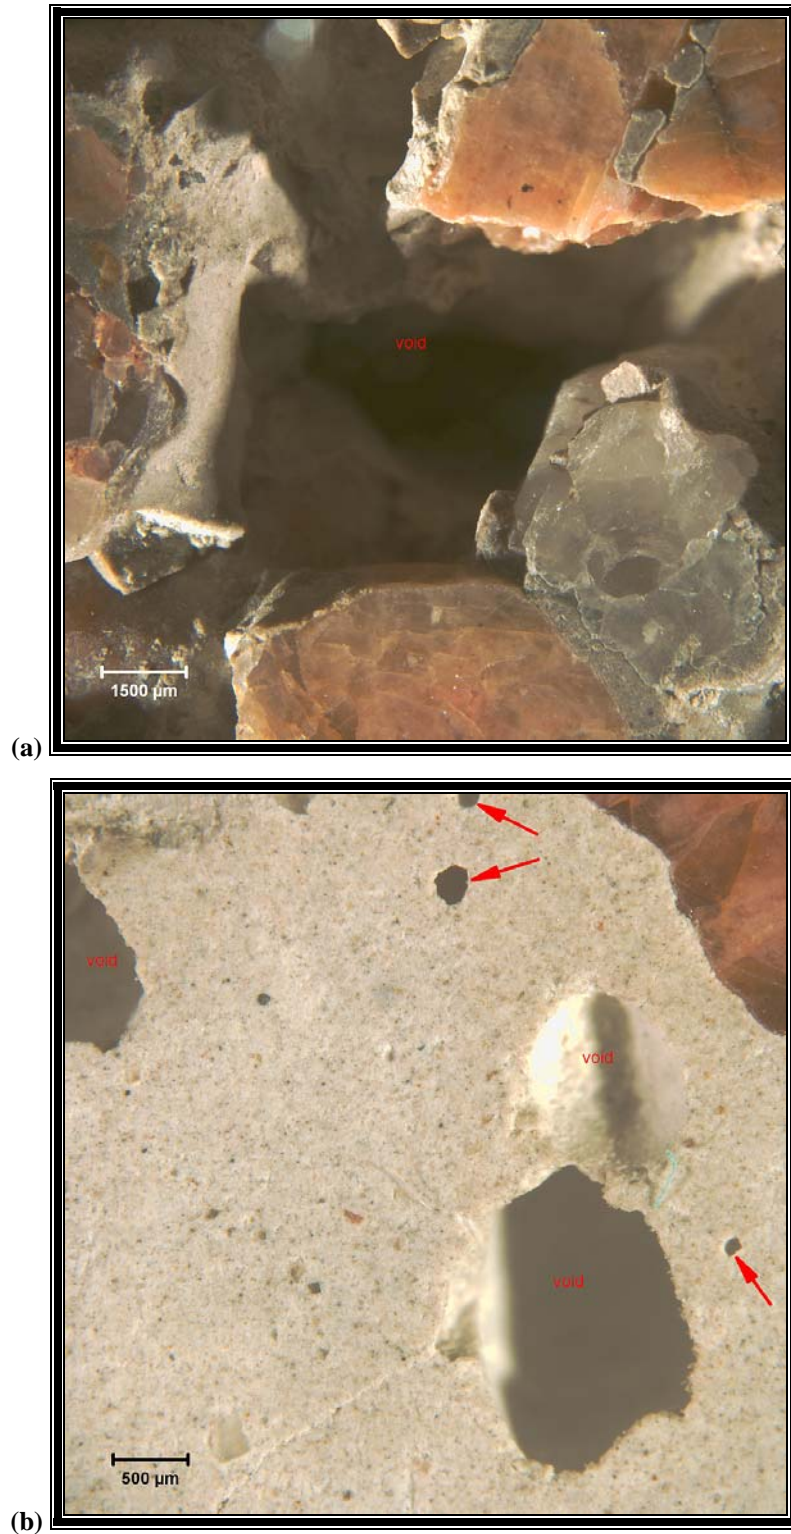
Figure A5. Reflected light photomicrographs of (a) a large void near the top of the slab and (b) smaller voids (red arrows and labeled) in the lower portion of the slab.

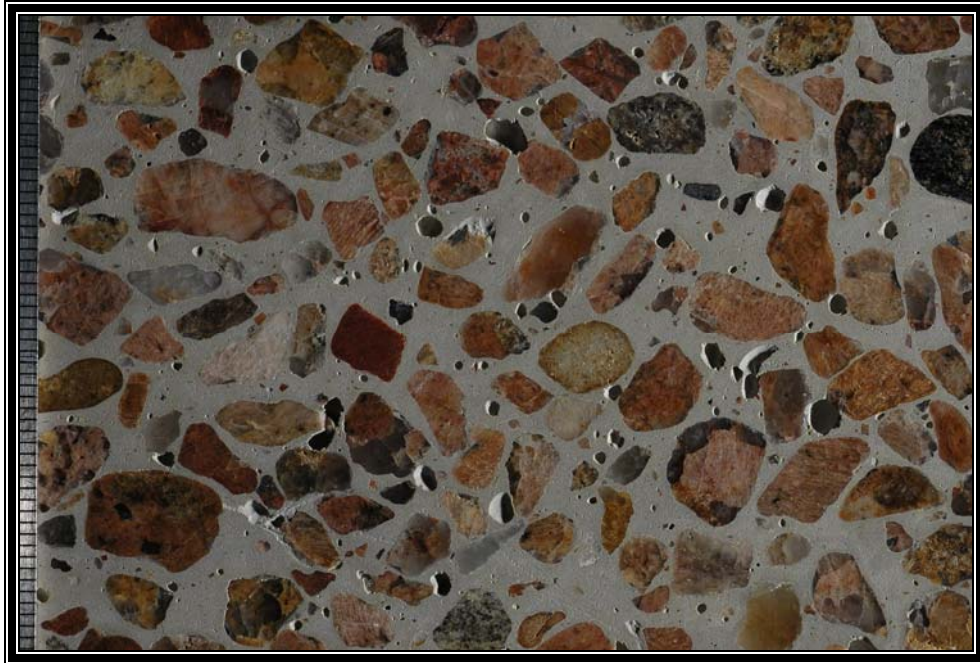
5. COARSE AGGREGATE	
PHYSICAL PROPERTIES	Natural gravel with nominal top size of 9.5 mm (¾ in.; Figure A6). The gradation of the aggregate appears limited to a few sieve sizes with no appreciable amount of sand present. The aggregate particles are typically sub-equant to oblong in shape with well-rounded to sub-angular edges. No preferred orientations were observed.
ROCK TYPES	The aggregate consists predominantly of granitic rocks (> 75%) that range in color from light pink to deep red to light gray. Other rock types that make up minor components (< 10%) of the aggregate include siliceous volcanic rocks, coarse particles of quartz and feldspar that appear derived from pegmatite, metagraywackes, and amphibolites.
OTHER FEATURES	No deleterious coatings or incrustations were observed. There is no significant internal microcracking of the aggregates and no evidence of reaction rims or other evidence of ASR. Low w/cm mortar coatings are present on many aggregate particles.

Figure A6. Photograph of polished surface showing overview of aggregate; scale in millimeters.

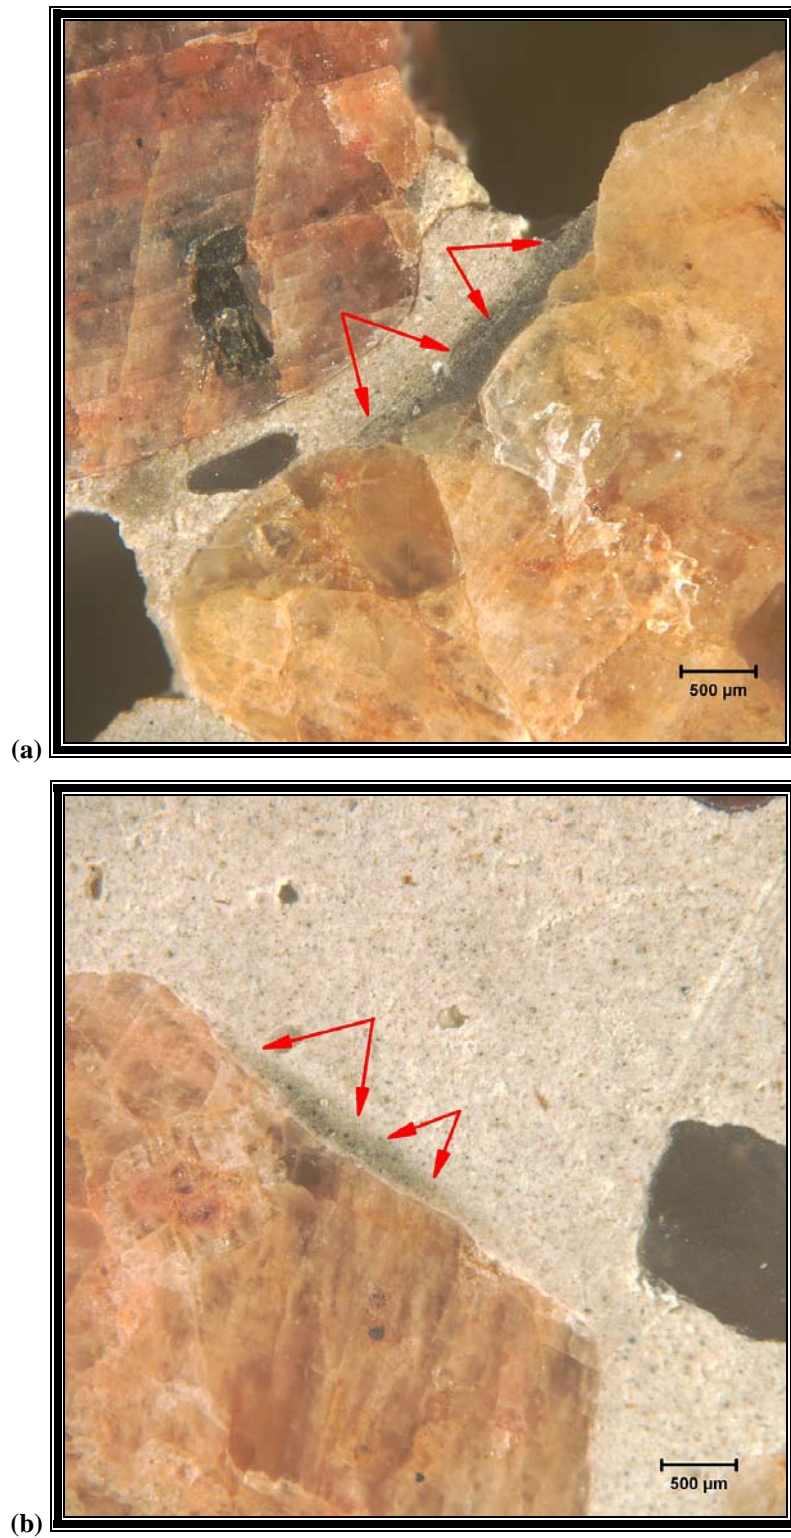
Figure A8. Reflected light photomicrographs of polished surface showing low w/cm mortar coatings (red arrows) on aggregates (a) near the top of the slab and (b) within the middle of the slab.

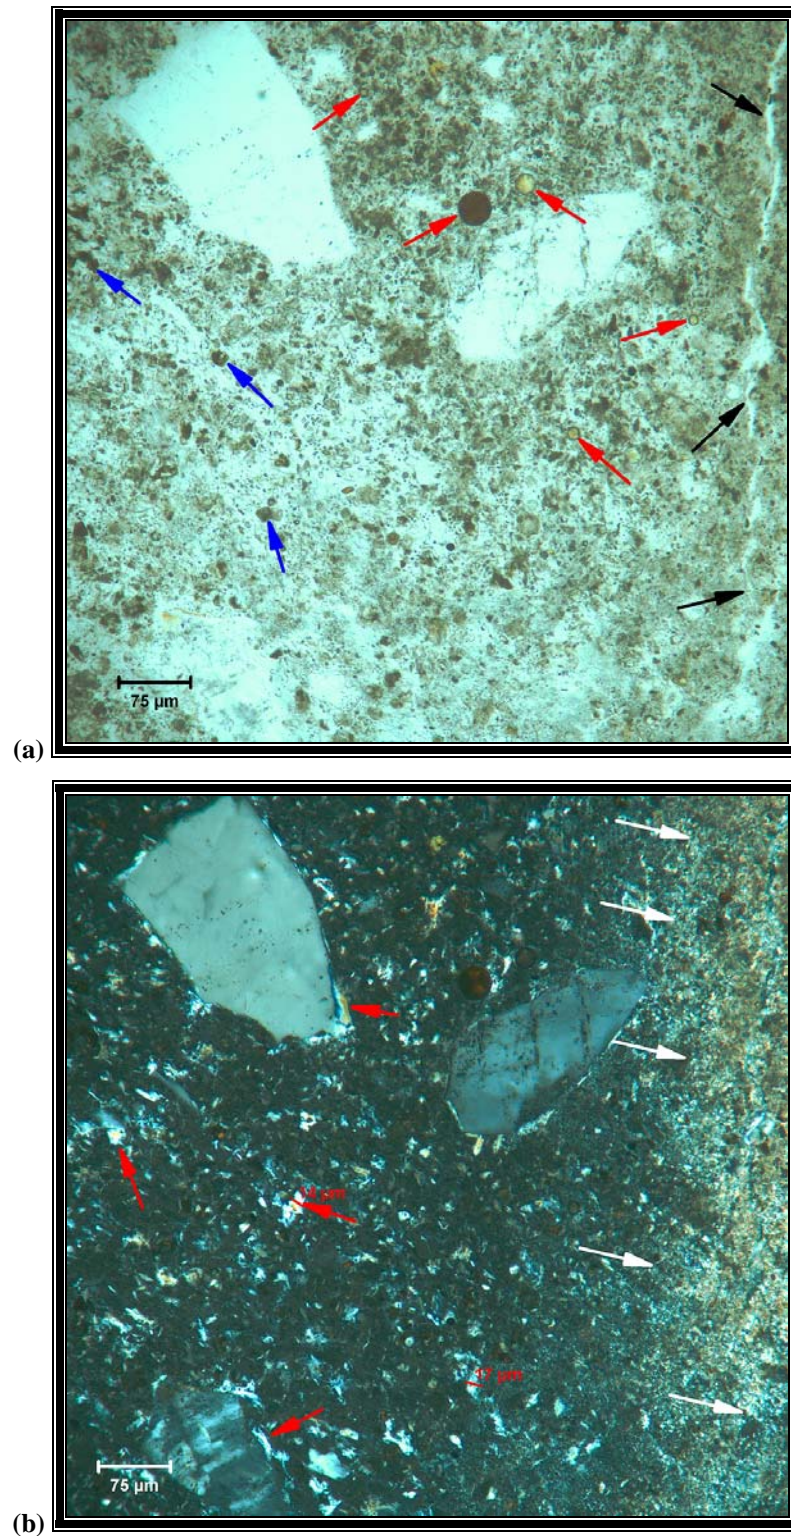
Figure A9. Transmitted light photomicrographs of thin section showing detail of paste in (a) plane-polarized and (b) cross-polarized light. In (a) red and blue arrows indicate fly ash and RRCG; respectively. The black arrows highlight a microcrack. In (b) red arrows and bars indicate CH; white arrows show carbonated paste adjacent to microcrack.

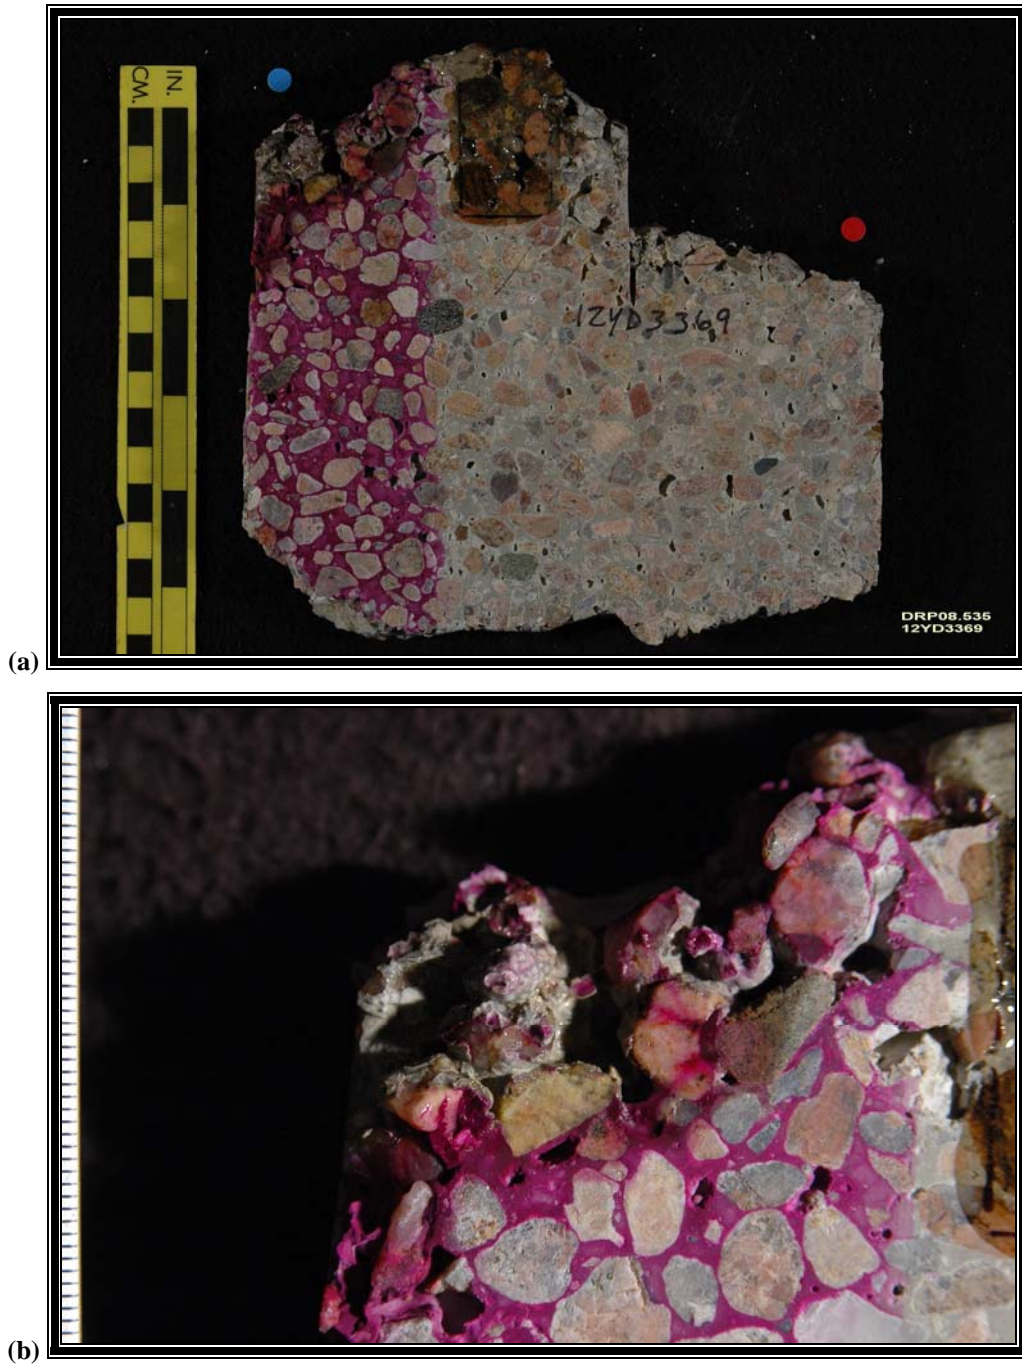
7. SECONDARY DEPOSITS	
PHENOLPHTHALEIN	Stains full depth of slab (Figure A10).
DEPOSITS	Minor carbonation observed around some cracks and microcracks. Traces of ettringite observed in rare voids.

Figure A10. Photographs of phenolphthalein stained surface showing (a) overview of stained slab and (b) detail of slab near the top surface. The scale in (b) is in millimeters.

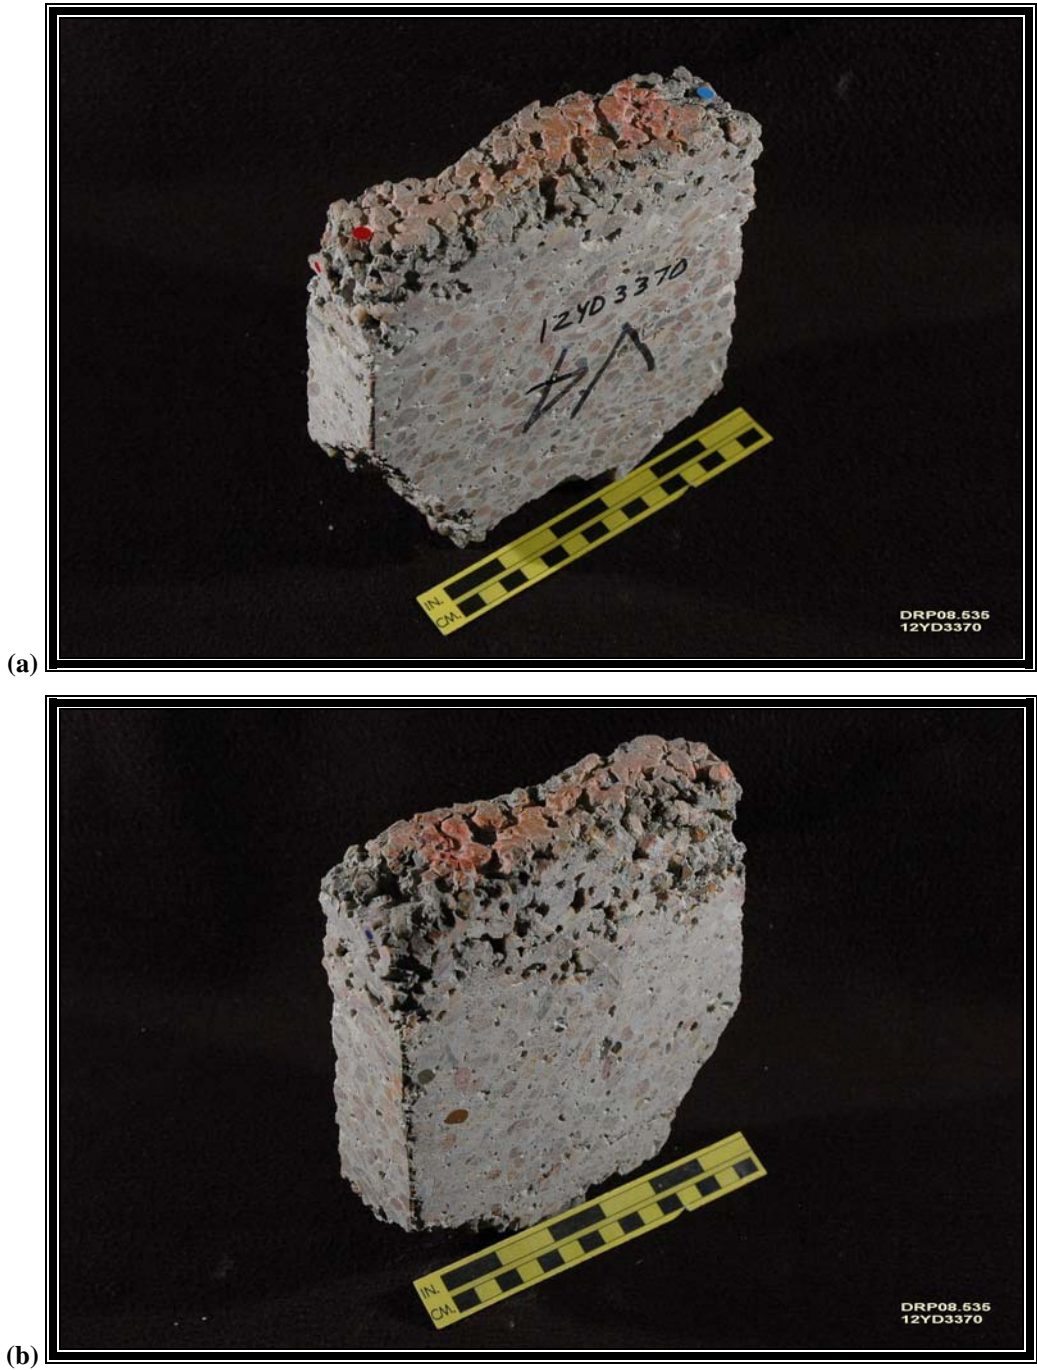
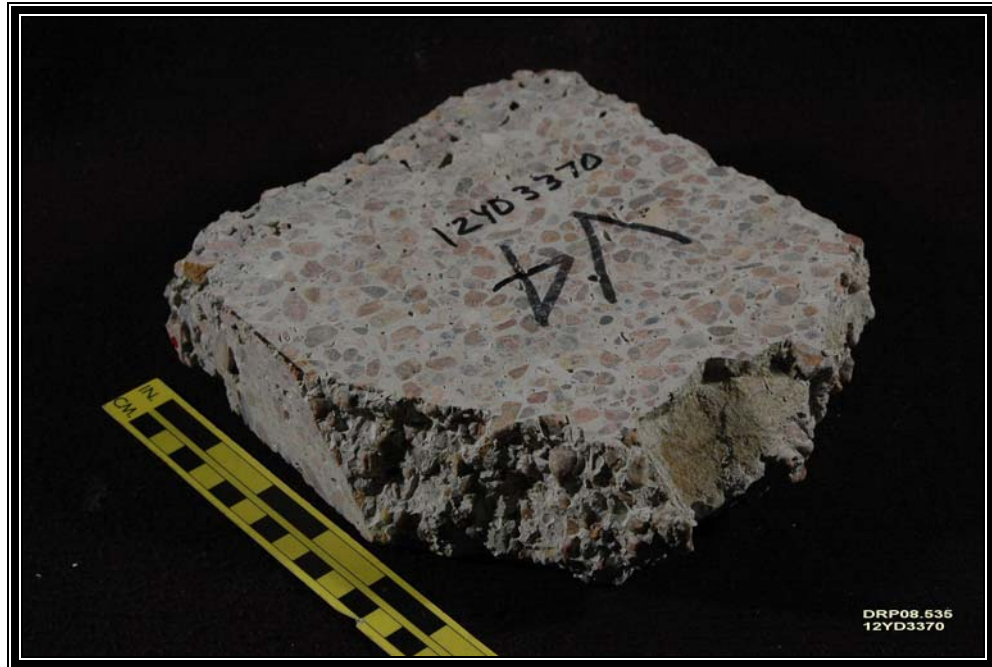
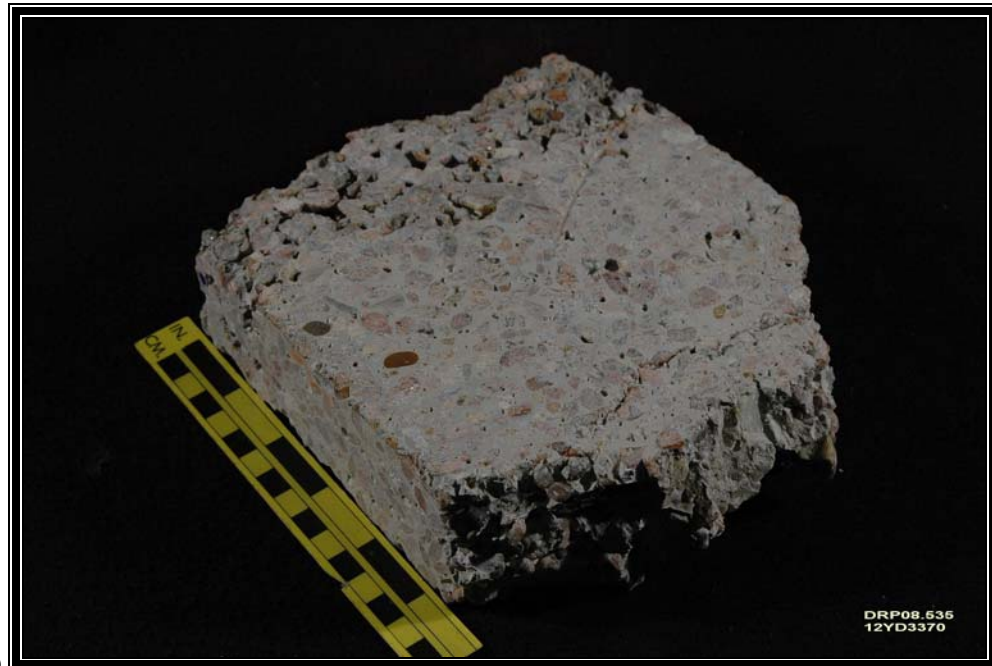
1. RECEIVED CONDITION	
ORIENTATION	Vertical block cut from concrete slab measures 170 mm (~ 6 ¾ in.) long, 50 mm (~ 2 in.) wide, and 163 mm (~ 6 ½ in.) deep (Figure B1, B2).
SURFACES	Top surface has float finish; bottom surface is a fracture. The block does not represent the full thickness of the pavement.
GENERAL CONDITION	Concrete is relatively compact and hard. No aggregate tears or unusual crumbling was reported.

Figure B1. Photographs of sample in as-received condition showing. Red and blue dots in (a) show orientation of saw cut.

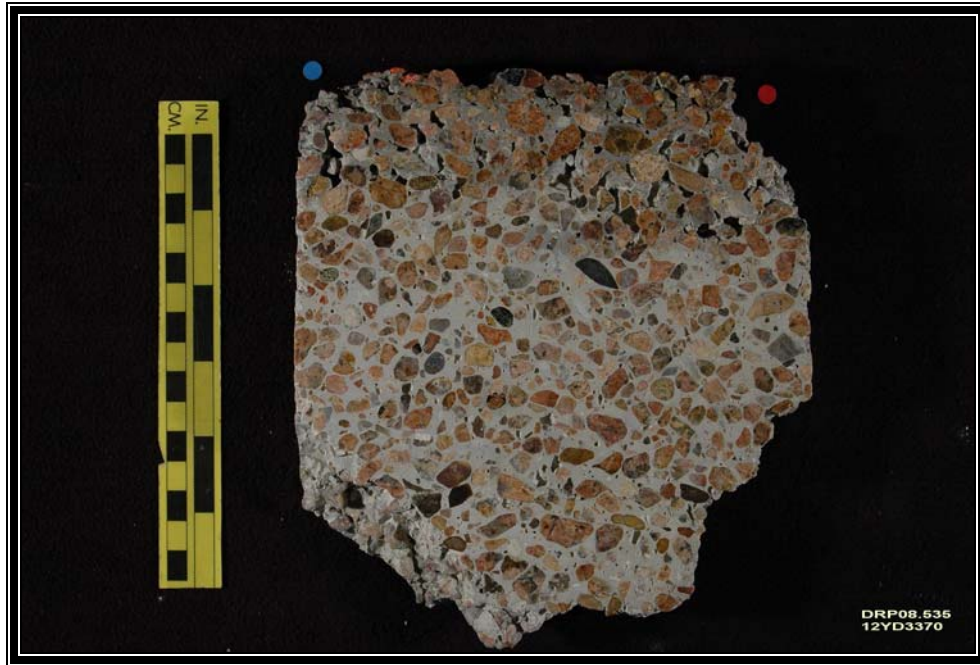
Figure B2. Photograph of polished surface of sample.

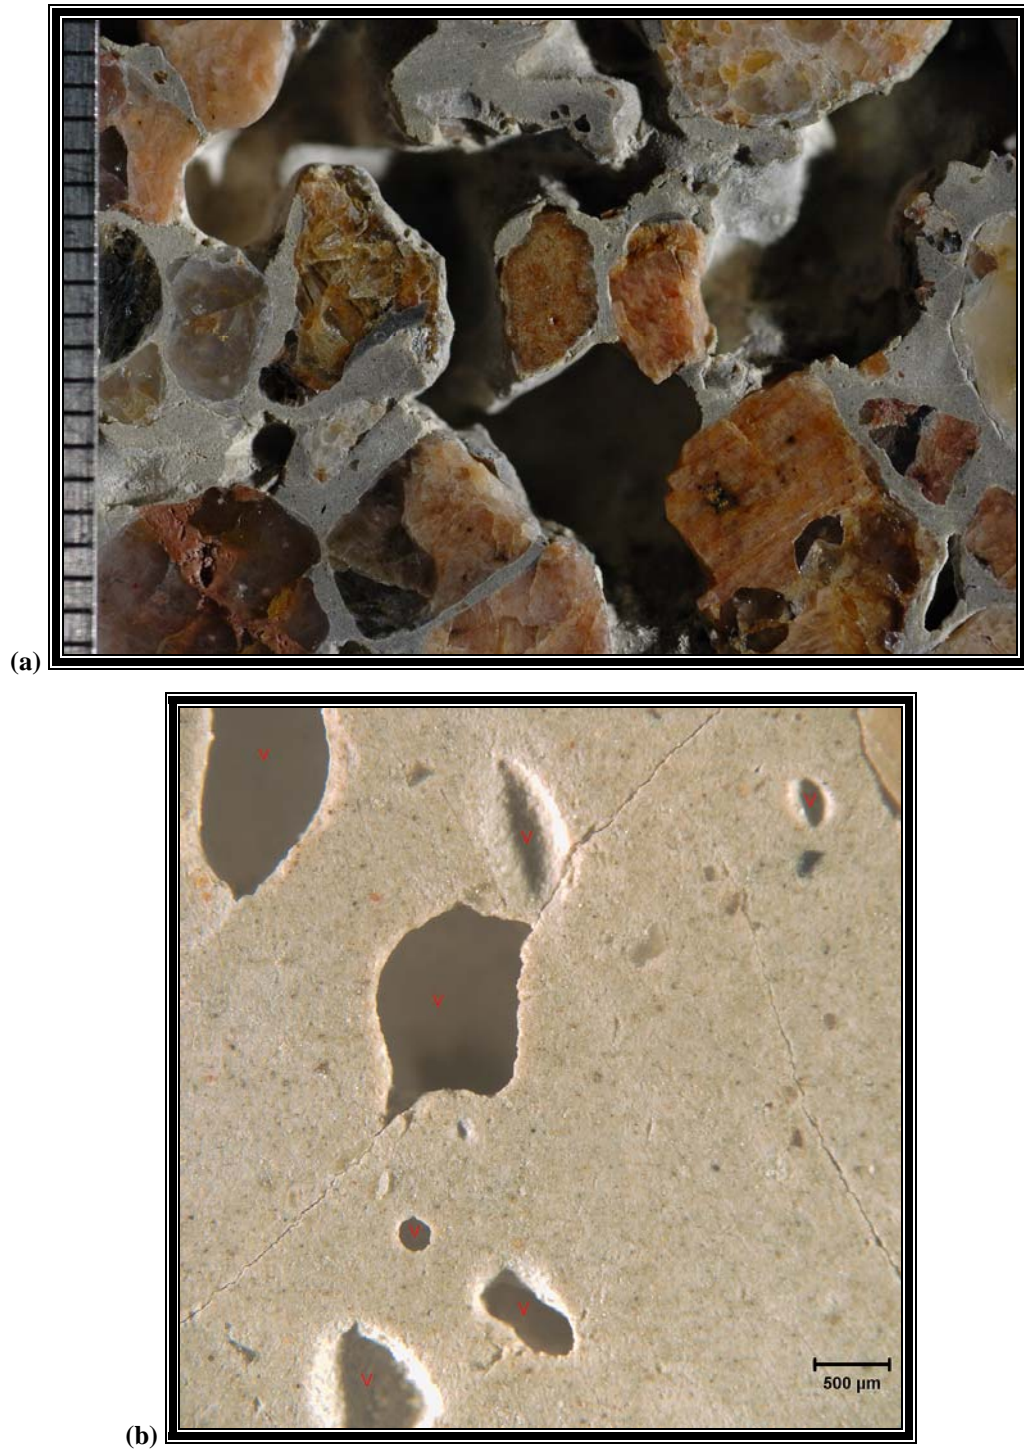
Figure B5. (a) Photograph of polished surface showing large voids near the top of the slab. (b) Reflected light photomicrograph of polished surface showing smaller voids (red “v”) in the middle of the slab.

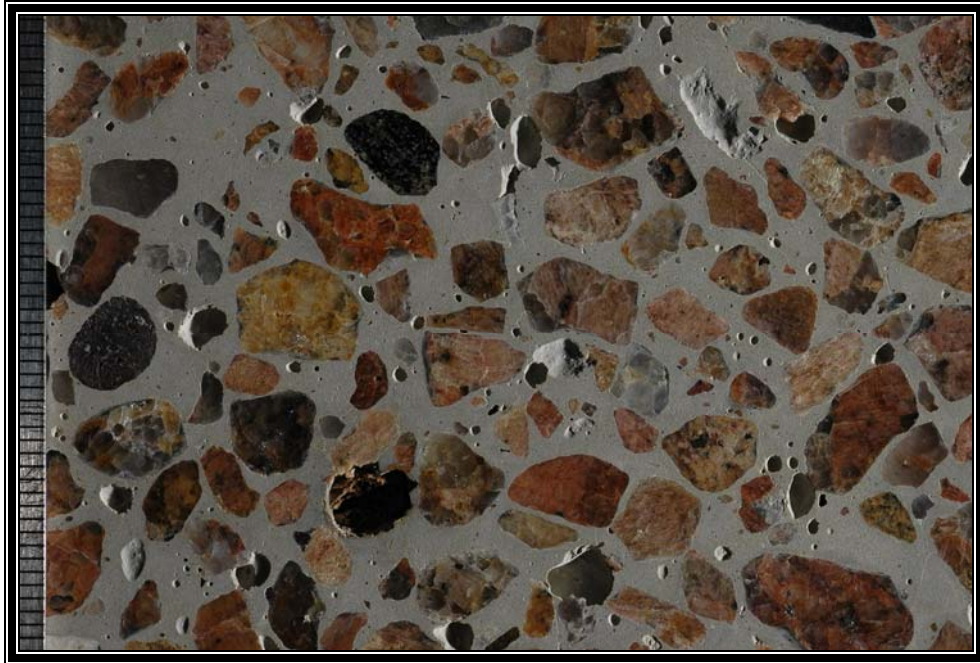
Figure B6. Photograph of polished surface showing overview of aggregate; scale in millimeters.

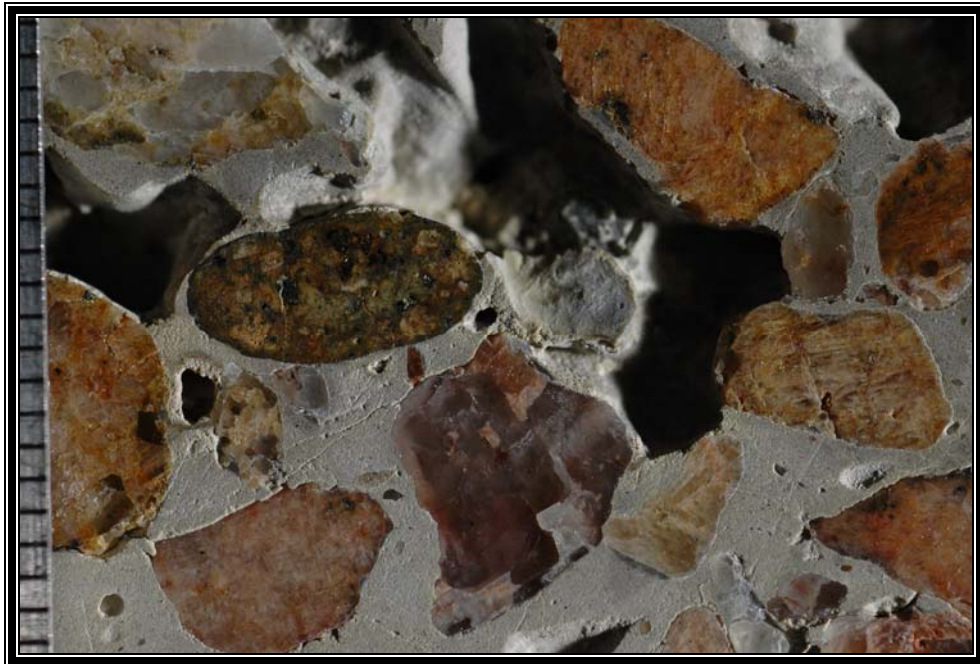
5. COARSE AGGREGATE	
PHYSICAL PROPERTIES	Natural gravel with nominal top size of 9.5 mm (¾ in.; Figure B7). The gradation of the aggregate appears limited to a few sieve sizes with no appreciable amount of sand present. The aggregate particles are typically sub-equant to oblong in shape with well-rounded to sub-angular edges. No preferred orientations were observed.
ROCK TYPES	The aggregate consists predominantly of granitic rocks (> 75%) that range in color from light ink to deep red to light gray. Other rock types that make up minor components (< 10%) of the aggregate include siliceous volcanic rocks, coarse particles of quartz and feldspar that appear derived from pegmatite, metagraywackes, and amphibolites
OTHER FEATURES	No deleterious coatings or incrustations were observed. There is no significant internal microcracking of the aggregates and no evidence of reaction rims or other evidence of ASR. Low w/cm mortar coatings are present on many aggregate particles throughout the thickness of the slab.

Figure B7. Photograph of polished surface showing paste color variations; scale in millimeters.

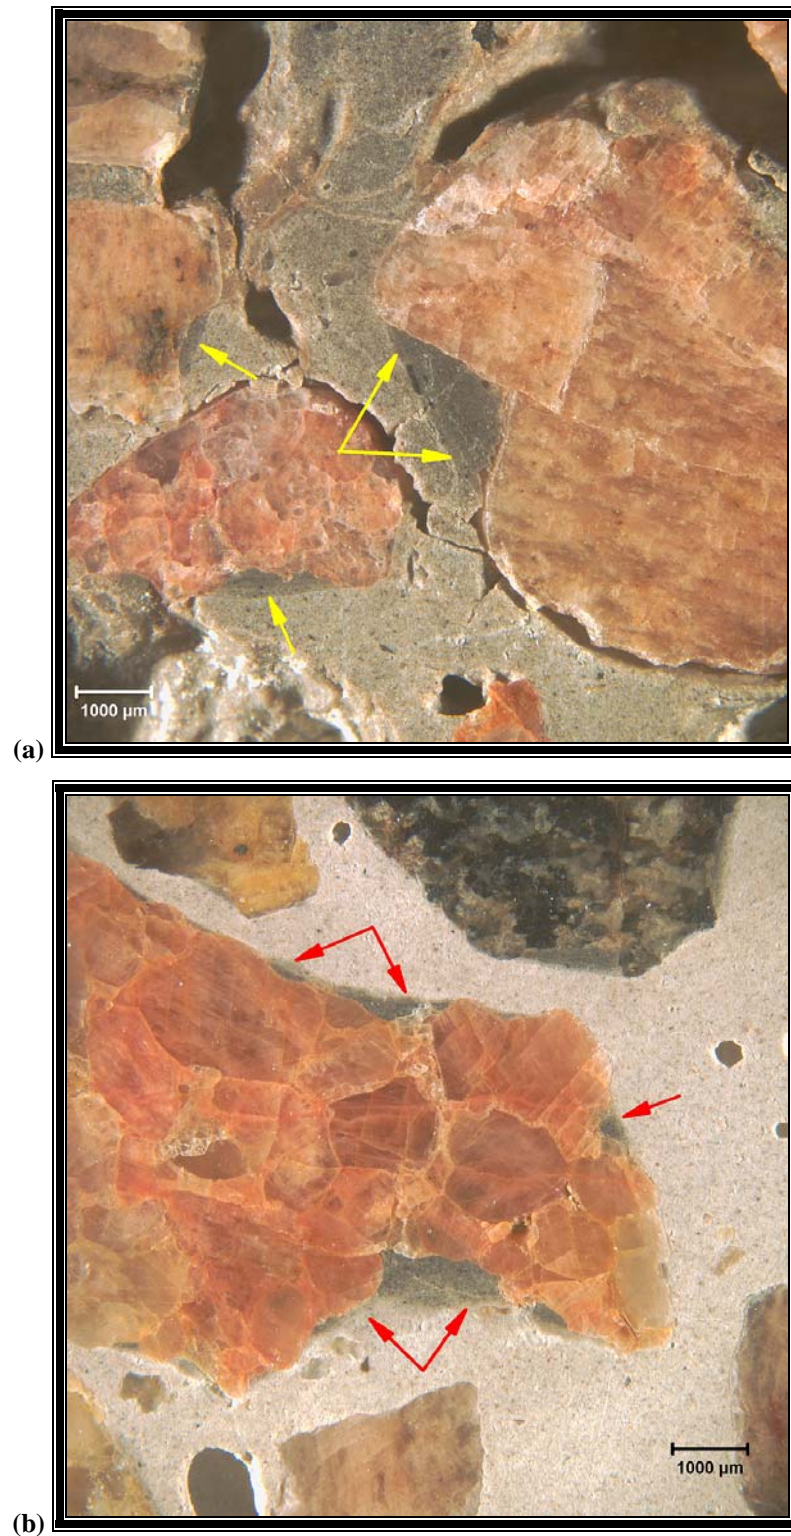
Figure B8. Reflected light photomicrograph of polished surface showing low w/cm mortar coatings (red arrows) on aggregates (a) near the top of the slab and (b) in the middle of the slab.

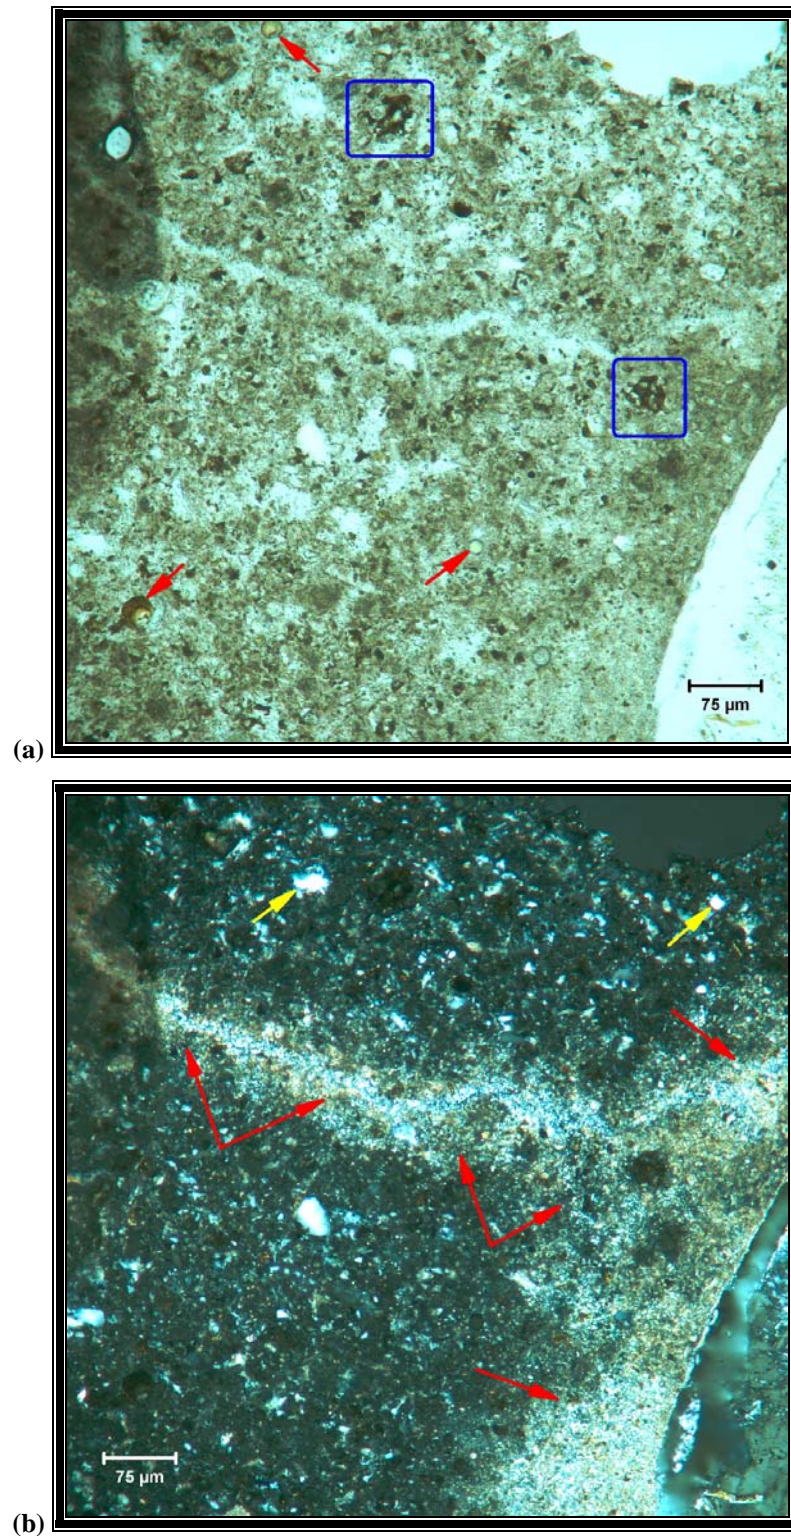
Figure B9. Transmitted light photomicrographs of thin section showing detail of paste in (a) plane-polarized and (b) cross-polarized light. In (a) red arrows indicate fly ash and blue boxes indicate RRCG. In (b) red arrows indicate carbonated paste along walls of a microcrack and yellow arrows indicate CH.

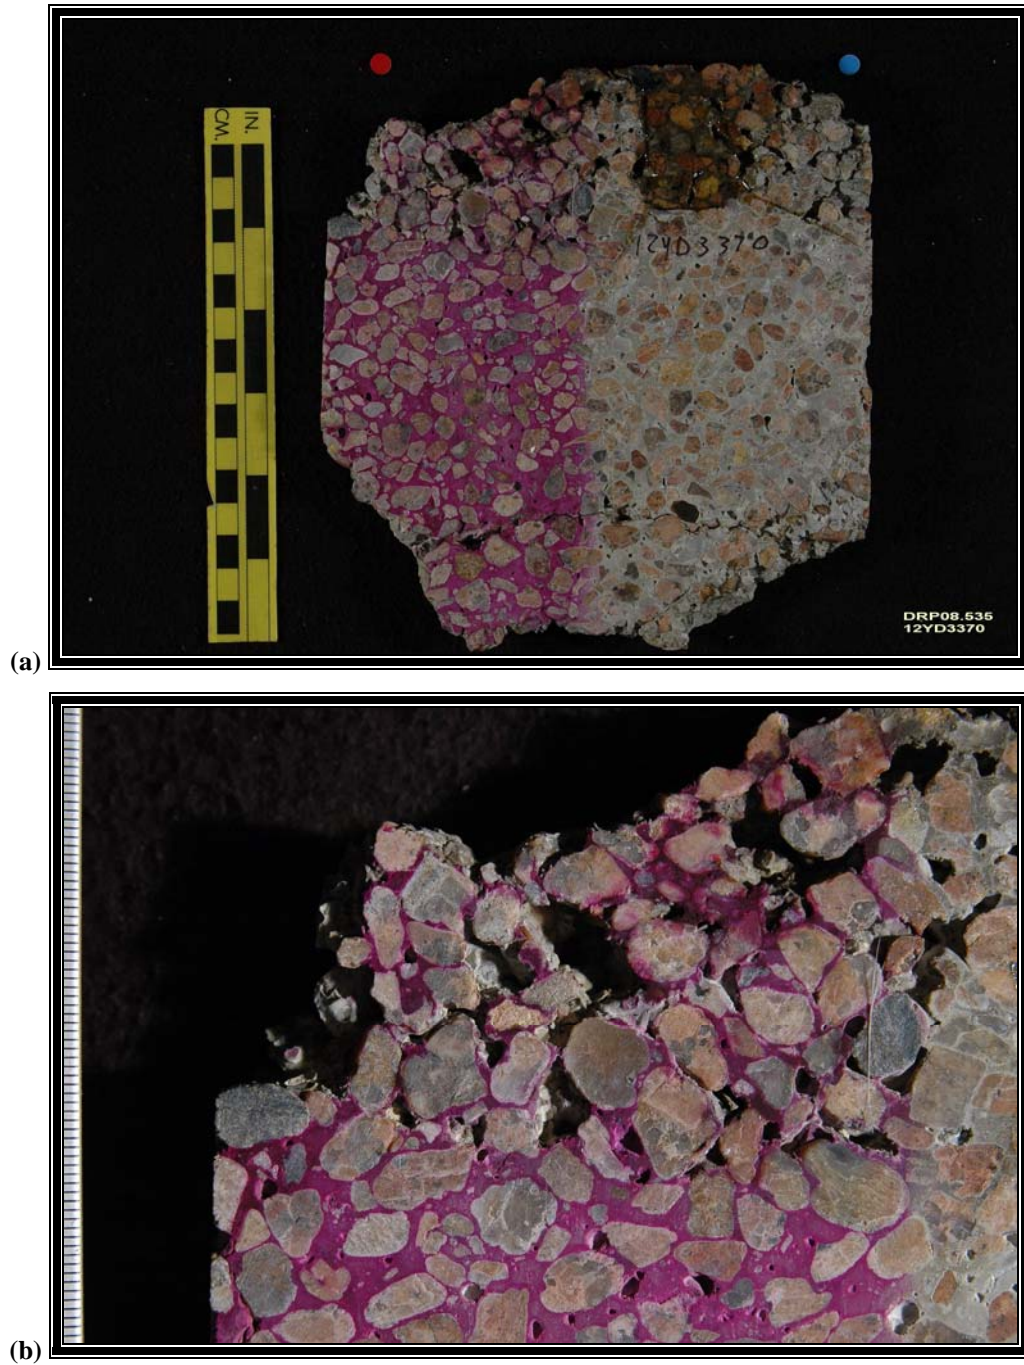
7. SECONDARY DEPOSITS	
PHENOLPHTHALEIN	Stains full depth of slab (Figure B10).
DEPOSITS	Minor carbonation observed around some cracks and microcracks and around some voids near the top of the slab. Traces of ettringite observed in rare voids.

Figure B10. Photographs of phenolphthalein stained surface showing (a) overview of surface and (b) detail of surface near the top of the slab. The scale in (b) is in millimeters.
